**ДОКЛАДИ  
МЕЖДУНАРОДНА НАУЧНА  
КОНФЕРЕНЦИЯ  
ПО ОПАЗВАНЕ  
НА  
НЕДВИЖИМОТО КУЛТУРНО  
НАСЛЕДСТВО  
БАНИ' 2022**

**PROCEEDINGS  
INTERNATIONAL SCIENTIFIC  
CONFERENCE  
PRESERVATION  
OF CULTURAL HERITAGE  
BASA' 2022**

| <b>стр. 282-306</b> | SEISMIC DAMAGE OF BUILDING STRUCTURES AND THEIR REHABILITATION<br><b>Radomir Folić, Miloš Čokić, Boris Folić, Angelos Liolios</b> |

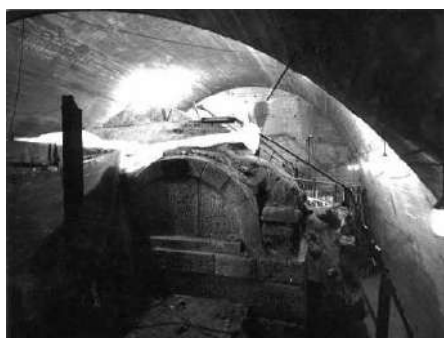
Fig. 18. Thracian tomb

This tomb (Figs. 18-20) was built in 4<sup>th</sup>-3<sup>rd</sup> century B. C. for a Thracian eminent ruler [2]. It is situated at an archeological reserve "Sborianovo" which comprises the territory of one of the most remarkable centers of the religious and political life in ancient Trace. The tomb illustrates the perfect construction technology, impressiveness, rich sculptor and painting decoration, high creation and talent of the genius ancient master. Therefore the tomb is included in the list of the world cultural heritage. It was discovered in 1982 excavating a tumulus. The tomb consists of a corridor (4,06 m long, 1,85 m wide and 2,15 m high) and 3 almost square cameras of different heights (4,55 m of the tomb camera and 3,25 m of the side camera). They were built by well trimmed stone blocks from white limestone and they were covered by semi-cylindrical vaults. The total dimensions of the tomb are 7,52 m long and 6,23 m wide at the facade. This unique monument of exclusive significance is a part of an unified architectural complex.

The structural and technological preservation, restoration and presentation of the tomb was a complex problem due to the following severe limitations: prohibition to the wet processes near the tomb, to keep the climatic conditions in the tomb, highest biological sterility of the used materials, maximal consideration and utilization of the soil properties (collapsible loess of second group), minimal risk, etc. Two temporary protection metal covering were mounted (Figs. 18, 19, 21) [17].

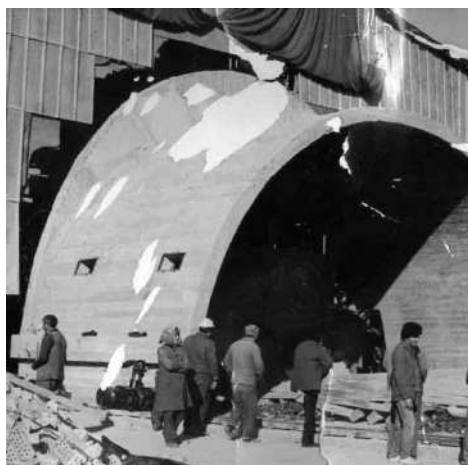
Fig. 21. Covering shell structure at the site

First one was also climatic and nearest to the tomb. It was assembled by the steel sheets simultaneously with the careful excavation around the tomb. A soil layer 60-70 cm thick was remained on the tomb to keep the internal climate. The second one was erected later on the tumulus part above the tomb and it was a tubular scaffold of large dimensions (about 18 m span) and far from the tomb. The constant covering is composed from two r/c cylindrical shells of equal span and 20 cm thick but of different radii of curvature (Fig. 21)

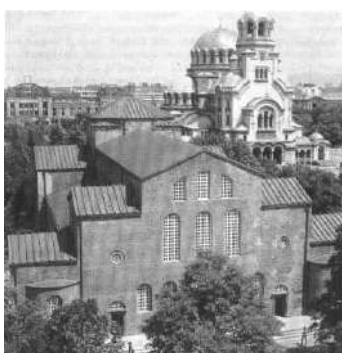
**Fig. 22.** St. Sofia basilika

This church is a unique monument from the early Byzantine construction. It dates from the second half of the 5<sup>th</sup> century [1], [2], [3]. It is a three auditorium construction with total length 46,50 m and width 23,00 m (Figs. 22, 23, 24). The central part of the structure is divided into three auditoriums by massive masonry columns with a cross-type cross-section. They are connected one another by arches without capitals. The main auditorium after crossing with the transverse auditorium continues with a same height in the altar space and forms a Latin cross. On the crossing place of the two auditorium a square is formed marked by 4 columns that sustains the main cupola by means of 4 triangular spherical surfaces. The cupola is hidden from outside by tetrahedron. In 1878 the main architect of Sofia the Czech L. Bayer and engineer Prosech pay attention to the church keeping and restoration. The basilica ‘Saint Sofia’ has almost 15 century history. It had been constructed for a long time. The structure has endured some strong earthquakes. The last reconstruction of the church has been made in 1930. Two investigations were made to evaluate the seismic vulnerability of the church. The first one is accomplished for the unstrengthened structure in 1989 by the computer programs COSMOS [8] and IES using 3D brick finite elements [5]. The second analysis is performed in 1998. In this study the spatial model is composed from existing structural elements from one side and some new strengthening elements (two reinforced concrete shells above the existing masonry domes and six tension bars of the roof arches and vaults) on the other hand [6]. The analysis is made by the finite element method (FEM) using also the COSMOS computer program [8]. The model contains 2475 finite elements and 2283 nodes with 6 DOF (3 displacements and 3 rotations) in each one (Fig. 24). The total number of equation is 12666. The following types of finite elements are used:

Many structural damages are detected [13]. Large cracks in vaults, domes and walls, soil settlements, deformations, decrease of the material strengths by the surrounding environmental effects, etc. are available. The main reason for damages are the past strong earthquakes. Some structural interventions are made during the last years to safeguarding of this unique and important monument in the center of Sofia. The investigations discovered that the structure responses as it is comprised of particular (isolated) fragments due to the deep and large cracks between them and insufficient contacts between the interventions. The structural spatial unity is slightly expressed. The basilica was very vulnerable to seismic actions. Therefore the effective structural measures were accomplished to restore the entire response of all structure. The cracks are filled up by injection of mix prepared by epoxide resin, stone powder and marble sand (Figs. 25, 26) [13]. A SIKA injection technology for restoration of the masonry continuity is applied. The large cracks are excavated 10 cm deep and enlarged to ease their injection. Some of cracks

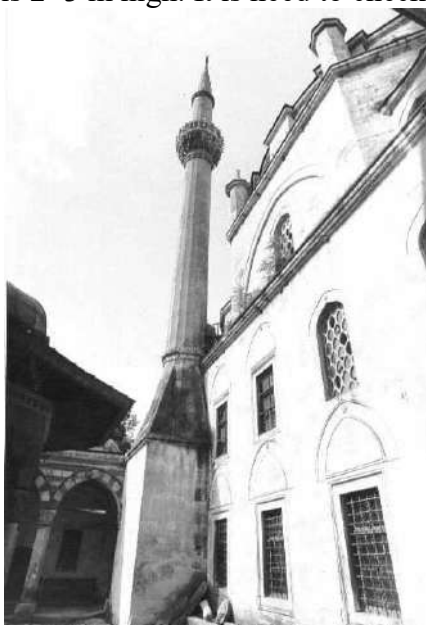
**Fig. 29.** Minaret in Shumen

The Tombul mosque (Figs. 29, 30) has been constructed in about 1743. The mosque minaret is 38,74 m high [21]. Till the +8,65 m level the minaret is joined to the mosque lower body but this connection is structural up to the +5,57 m level only. The minaret main high prismatic part has a circumcircle diameter of 1,70 1,53 m and wall thickness of 23,0 18,5 cm. The aboveground minaret structure up to the +30,55 m level is constructed by stone masonry. The principal damage of the minaret masonry is series of particular almost vertical cracks at the foot of the main prismatic part (Fig. 30 a). The cracked sector is 2 3 m high. It is need to check the minaret safety.

The full-scale dynamic tests of the minaret part between the 0,00 m and +25,41 m levels have been done (Fig. 30) [24]. The masonry part of the minaret structure between the levels of +5,57 m and +30,55 m is studied numerically also (Fig. 30) [21]. It is modelled as a vertical plane cantilever beam-column rigidly fixed at its bottom to the minaret low body (Fig. 31). In order to consider all structural features the beam is divided into 20 finite elements. The linear dynamic, static and stability analyses of the model are accomplished by the FEM and ROKU program [22]. The well known uniform beam-column finite element of six DOF is used. The seismic loads, the dynamic and resonant wind loads are determined by the response spectrum method according to [7] and [25]. The structure static stability is verified and then the higher-order bending moments caused by the vertical loads on the deformed beam axis in small displacements are computed by the iterative Vianello-Dischinger's method. The cross-section bearing capacity is checked by the stresses.

A good agreement between experimental and numerical results is obtained. The structure safety is not ensured due to the horizontal loads. Therefore an urgent strengthening of the stone masonry is need to be made only from inside by an appropriate way to restore the minaret normal safety in accordance with the current Bulgarian design codes. The strengthening should cover in height the whole internal surface of the masonry wall or at least the unsafe lower portion of the main prismatic part. Two alternative ways for repair and strengthening are discussed in [21], [23]: prestressing by internal vertical tendons and construction of an additional internal reinforced concrete skin. The first seems to be a simple and elegant solution which would leave no visible traces. However it was considered as impractical because the masonry cross-sections will be too heavily loaded to withstand the additional compression from the necessary prestressing force of about 1000 kN. Nevertheless the first way was adopted but it was not been applied due to financial shortage. Moreover several cracked stones can be replaced by new hard ones. Probably the

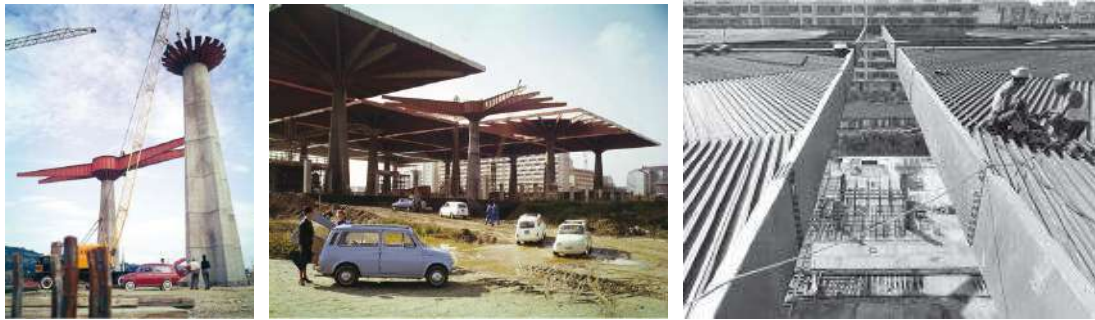
**Fig.7.**The construction of the “umbrellas”

**Fig.8.**The construction site

Apart from the technical or purely quantitative data – 158 meters long by 26 meters high with 650,000 m<sup>3</sup> of volume – the construction site and its organization constituted the most innovative aspect. The building works started with outlining the foundations on 1 February 1960 [29] and the construction was finished on 31 December of the same year [30]. The excavation and backfilling began in mid January and went on until April, while the palification of the foundations was concluded in June [31]. The foundations were outlined at the same time as the plinths and load-bearing walls: work on continued into August as they were built step-by-step the pillars were while being completed. About 300 people

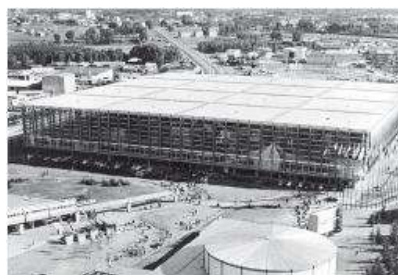
**Fig.15.** The roof before (left.) and after (right) the addition of the cooling/heating pipes, 1961-1965.

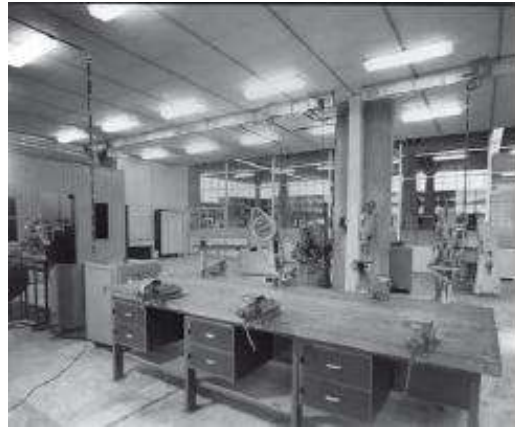
**Fig.19.** The interiors with false ceiling covering the isostatic ribbed slabs

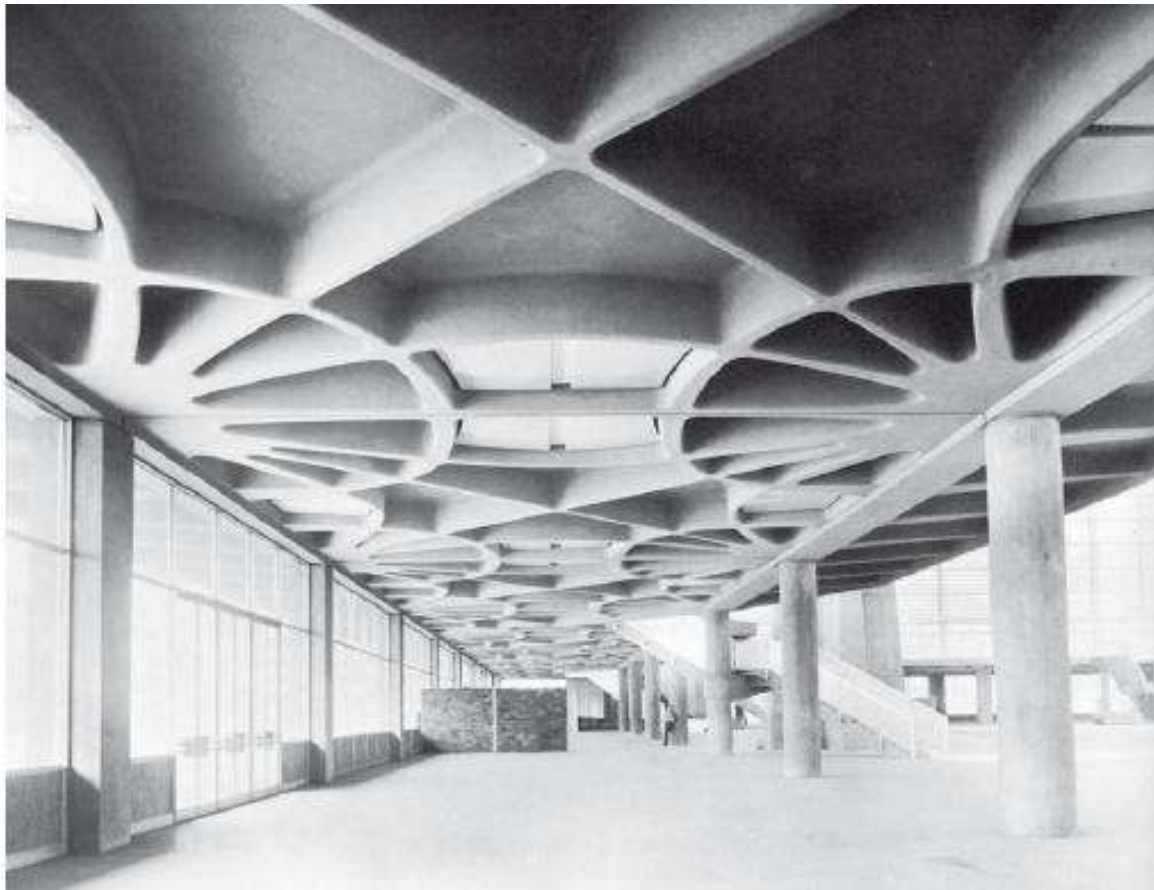
**Fig.20.** The original ceiling with isostatic ribbed slabs

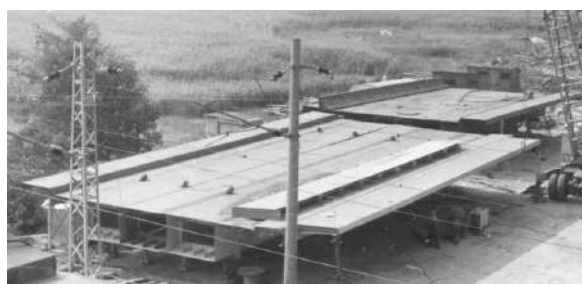
Fig.3. Triple-box section of the bridge deck

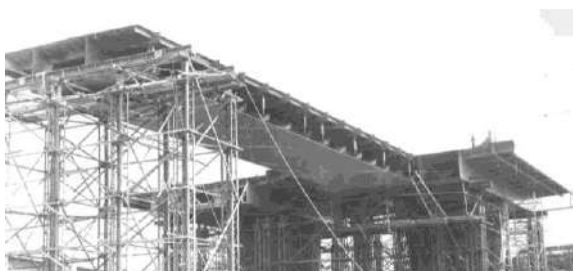
**Fig. 4.** Assembly of the box girders

The r/c foundations are initially cast-in-situ. The steel superstructures are assembled by a crane using prefabricated elements. In longitudinal direction 8 mounting sections are formed. In transverse direction 5 mounting deck sections for each of two decks are produced. The supports and columns are initially mounted to bases. Then the deck elements are lifted and joined to each other. High-strength bulgarian steel and welded junctions are implemented. The girders were taken to the construction site where they were lifted into their final position with a mobile crane “Demag”, (Figures 4 and 5).

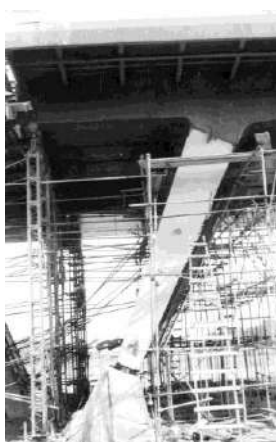
**Fig. 6.** Connection of the “V”-support to the lower orthotropic steel deck

Each deck has a roadway of 7,5 m width with two one-way lanes. The steel decks are stiffened by longitudinal and transverse ribs. Transverse diaphragms over the supports and between them are also constructed. Some parts of the two steel decks have different and variable curvatures and crosswise slopes. A dividing longitudinal middle gap is available between adjacent decks. The V-type supports are rigidly connected to the decks. The r/c supports are also rigidly linked up the foundations but the steel supports are tied by cylindrical hinges to the bases. The two middle vertical r/c columns of the steel bridge part has a rectangular variable cross section and they are bound by elastomeric bearings to the steel decks but by rigid couplings to the foundations. The adjacent V-type supports as well as the columns of the two decks are connected to particular r/c foundations (Fig. 6 and Fig. 7).

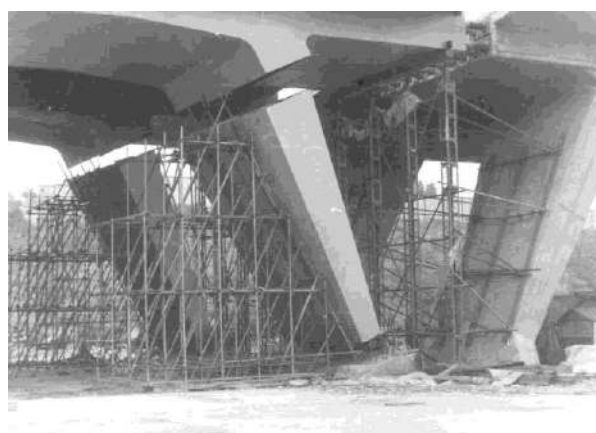
**Fig. 7.** Assembling of the steel “V”-supports

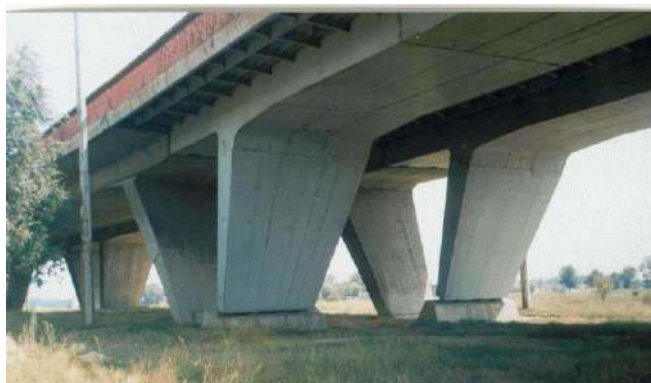
**Fig. 8.** A view of the concrete and steel bridges

The steel orthotropic bridge over the railway Sofia-Varna is an example of an effective structural method for medium span bridges. It is applicable for spans of 20-60 m considering that the prefabricated steel components are transported by road. To achieve of design versatility with the use of steel as a building material, a visually attractive structure could also be created. Since the region of Sofia is an active earthquake area, seismic codes had to be considered. However, the structure was proven to be ideal for earthquake regions. The superstructure with small mass, together with the inclined supports and columns formed a structure with excellent stiffness. A high level of precision was required during the process of construction, since much of the work had to be carried out in advance under the factory conditions. The technical tests proved the high quality of the structure. This important and complex bridge has been operating successfully about 40 years (Figs. 8 and 9).

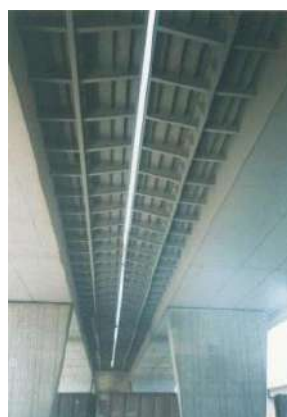
**Fig. 9.** A view from beneath the steel orthotropic bridge

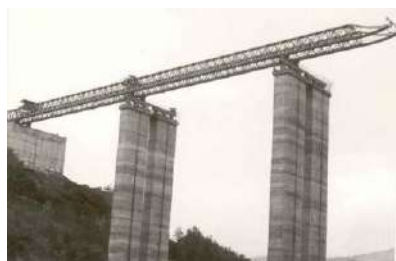
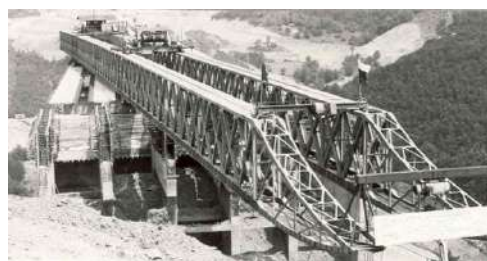
**Fig.10e,f.** Overall view of the steel trusses – e); Cross-Section 3-3 and 4-4 of the two Trusses – f)

The rational installing structure and the mounting technology are proposed, elaborated and applied successfully. The structure of the installing equipment, the lower adjusting rolling trucks, the upper installing rolling trucks and the installing technology are technical novelties and inventions. These unique structure and technology are very effective, reliable and fine(Figs.10e,f).

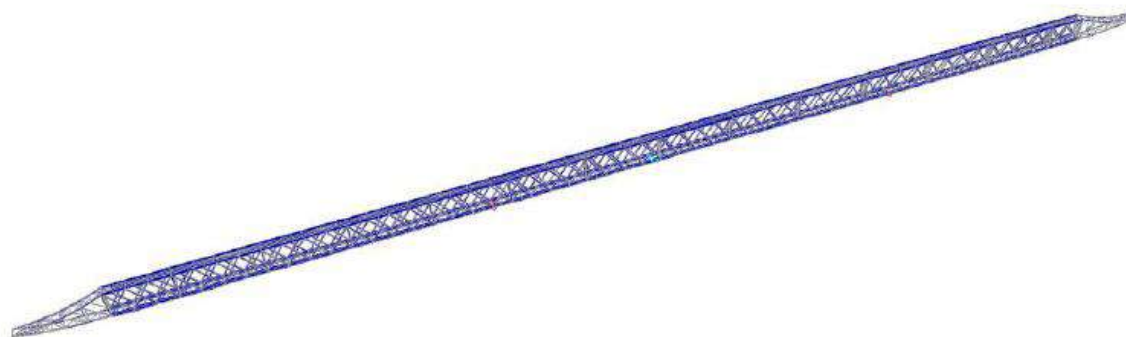
**Fig.10g.** 3D FEM of the double twin gantry truss with 168m length

Before using the gantry truss for transporting the 60m bridge girders with 220ton weight Bulgarian Road Agency[2] performed series of load tests to prove its load bearing capacity and compare the structural behavior with the project developed. Under load and support conditions in accordance with schemes SH 1.1, SH 2.1, SH 2.2 and SH 2.3 vertical displacements of the particular measuring points are measured by means of Maximov's deflecto-meter and with precise geodetic level measurer "KONT".

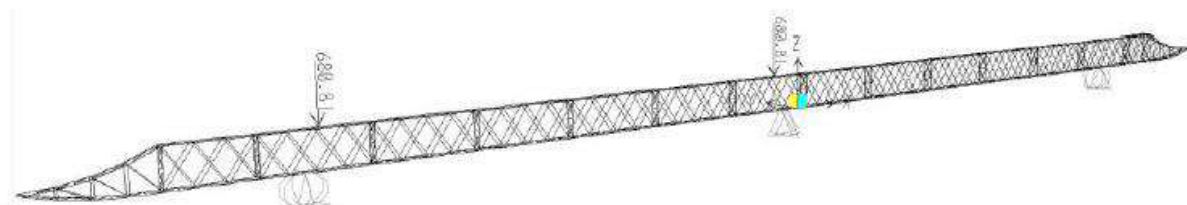
**Fig.10i.** Support conditions and loads arrangement for scheme SH 2.1. ( $F=680.81\text{kN}$ ).

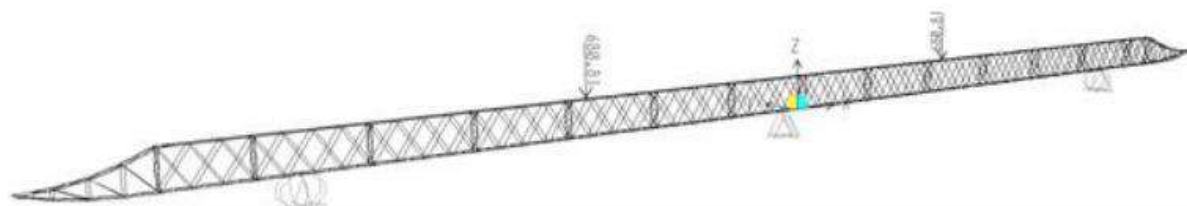
**Fig.10j.** Support conditions and loads arrangement for scheme SH 2.2. ( $F=680.81\text{kN}$ ).

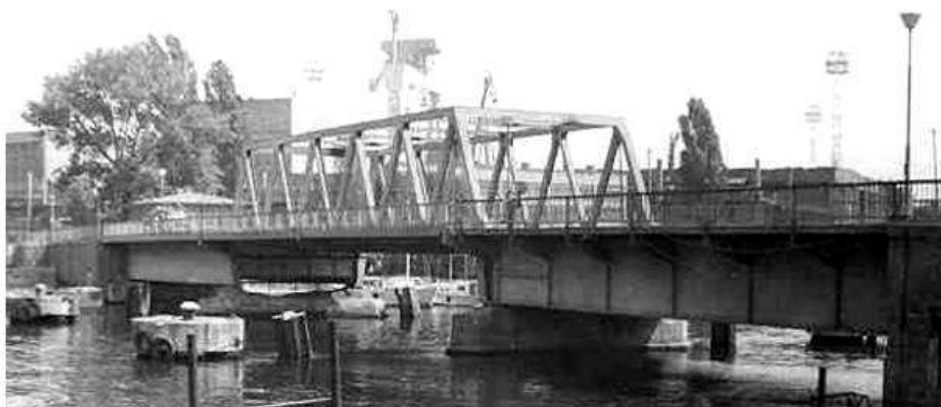
**Fig. 18.** View of the completed bridge

The design and construction of the small Asparuhov bridge was executed without interruptions, due to the importance of the project to the national economy. The orthotropic structures were designed to modern standards, and were completely shop-welded at the Varna ship-maintenance yard. The design and construction were executed in parallel, which resulted in a fairly short completion period; just three months. All works, and the welds in particular were subject to strict quality control. All butt welds were X-ray inspected. A defective weld would then be removed, welded and inspected again. The bridge structures were shipped to site by a 100t Gants floating crane. The final assembly was done by simply placing the assembly units at their design locations. The assembly process went smoothly and was completed in a few days. The total weight of the structures was 81t. for the stationary part and 113t, for the movable part. The quality control for the design calculations and drawings was done by Prof. Dr. Hristo Popov, a prominent Bulgarian expert in steel bridges.

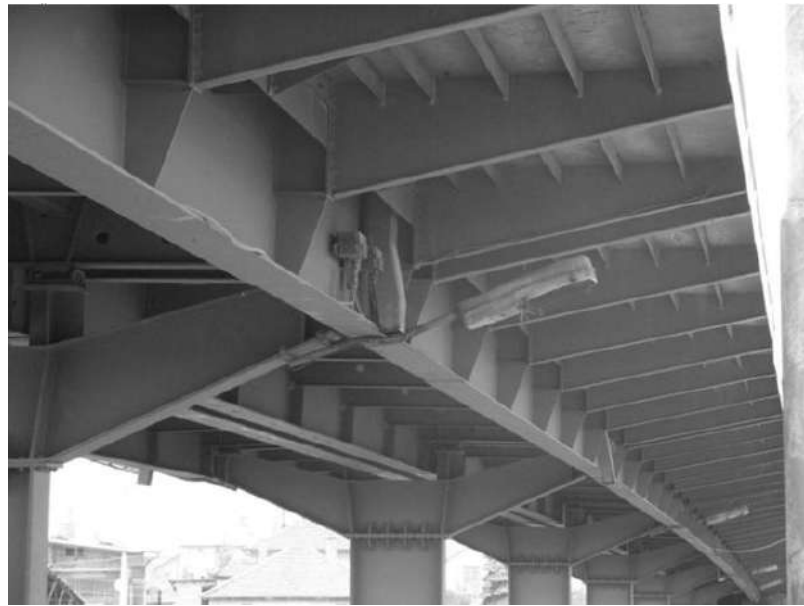
**Fig. 22.** View of the sidewalks of the completed bridge (bottom).

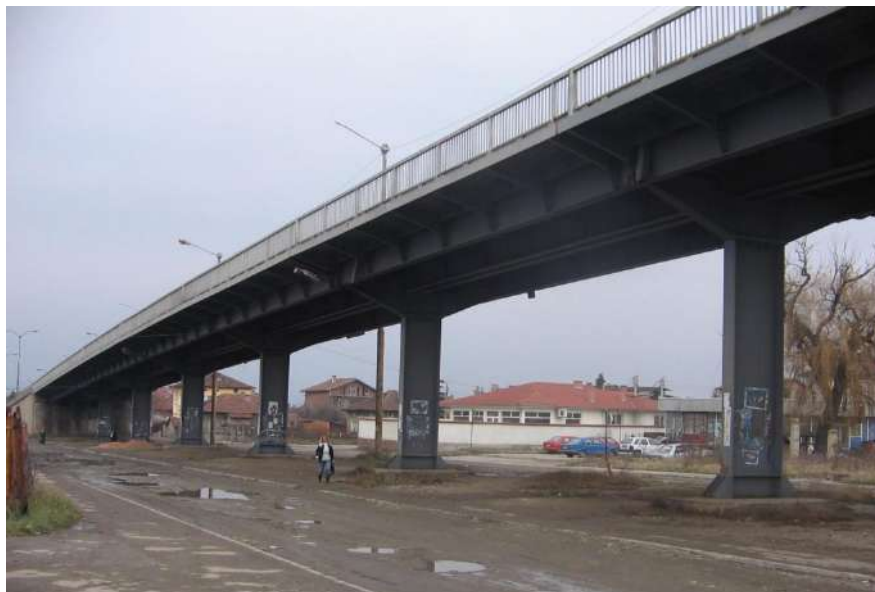
**Fig. 23.** The completed bridge

The structure is delivered from the workshop coated with two layers of primer and painted. Two additional layers of paint were applied after assembly. The road surface – 7mm “Road coat” type was applied in two layers on site after assembly.

he total weight of the structure is 9890 kN. The design was submitted for review in June 1980, static and dynamic testing was carried out by the Road Institute (Bulgaria), and in May 1981 the facility started operation. A view of the completed bridge is shown in Fig. 23.

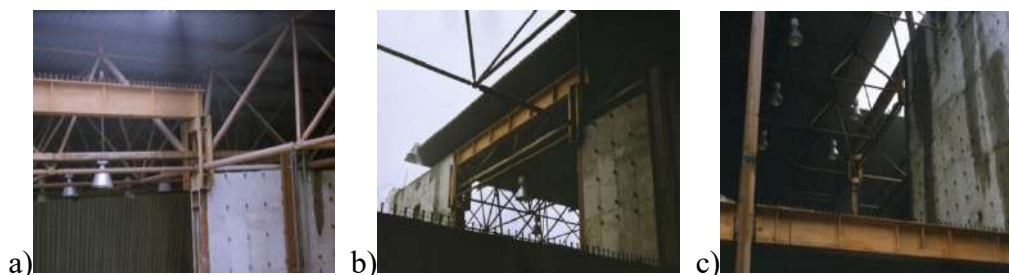
**Fig.9a,b,c.** Special box structures left in the reinforced concrete diaphragms

Of particular interest are the details of the spatial strengthening of the three-story administrative building [3], next to the hall, in which part of the rod members of the spatial structure had to pass through special box structures left in the reinforced concrete diaphragms (Fig.9a,b,c and Fig.10a,b,c).

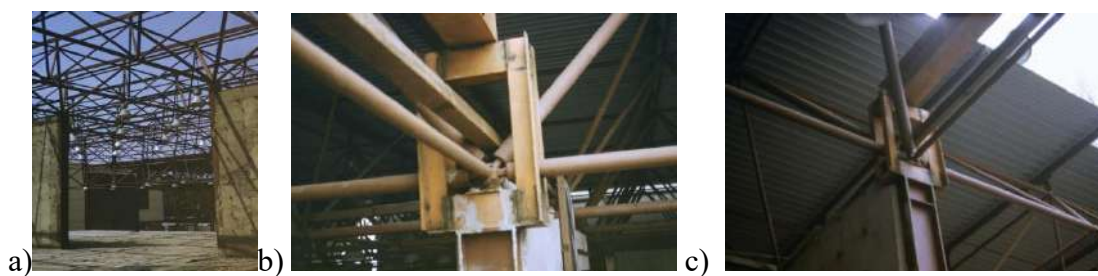
**Fig.10,a,b,c.** Special box structures left in the reinforced concrete diaphragms

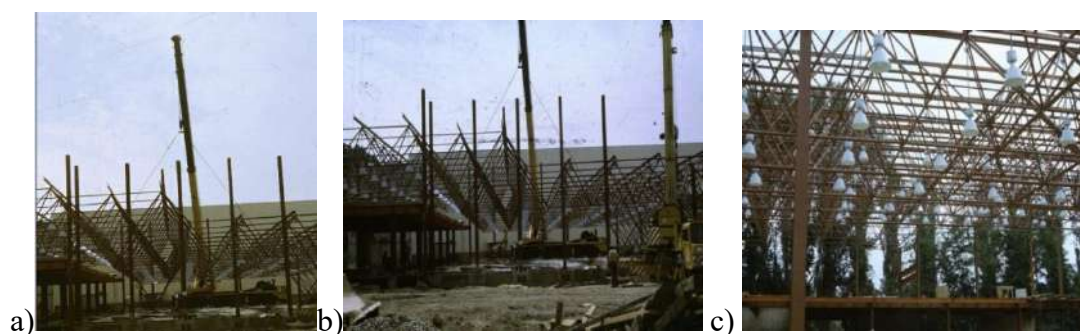
**Fig.14a,b,c.** Technology of installation of the steel structure

The structural plate between axes 9 and 17 is assembled on the prepared site, after which it was raised with a capital to a height of 2.12 m, above the site elevation. Next, a structural mesh was assembled between axes 16 and 19. Using an elevation of +3.60 m for an assembly platform, the structure between axes 1 and 19 was also assembled. In total, the installation of the entire structure was carried out by 4 installers at the Druzhba plant in 14 days. The installation of the roof structure together with the capitals, chairs, purling and lighting fixtures was carried out by three cranes. (Fig.14 a,b,c and Fig.15a,b,c) on 13.08.1987. The roof construction is assembled synchronously at the level:  $\pm 0.00$  and +3.60 m for 7 days by 4 workers and erected in place with the aid of three cranes "Liebherr", "Grove", "Faun".

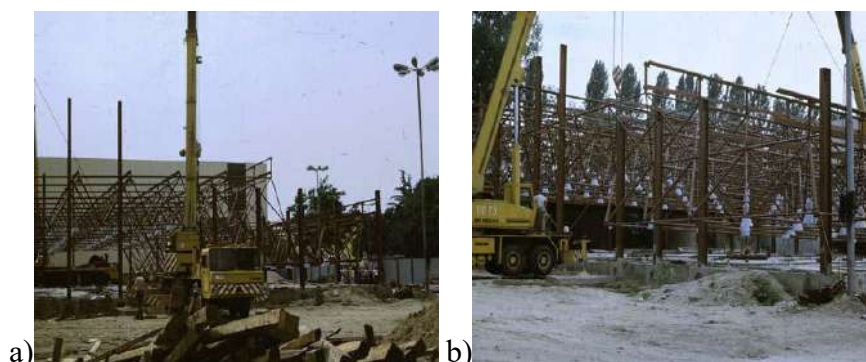
**Fig.15a,b.** Assembly - view: north –a); Installation - view: west –b)

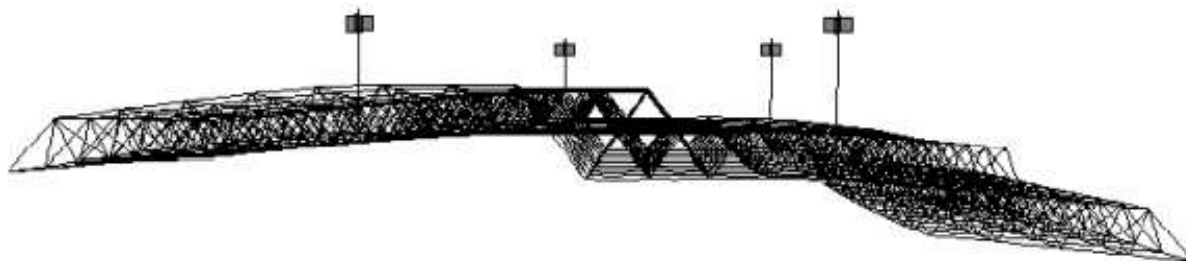
**Fig. 18.** The structure in the assembled state

During the geometric construction of the model and its discretization, a mesh of 3656 frame elements and 4984 shell elements was generated. The spatial rod construction consists of 1595 frame elements (Fig.18)

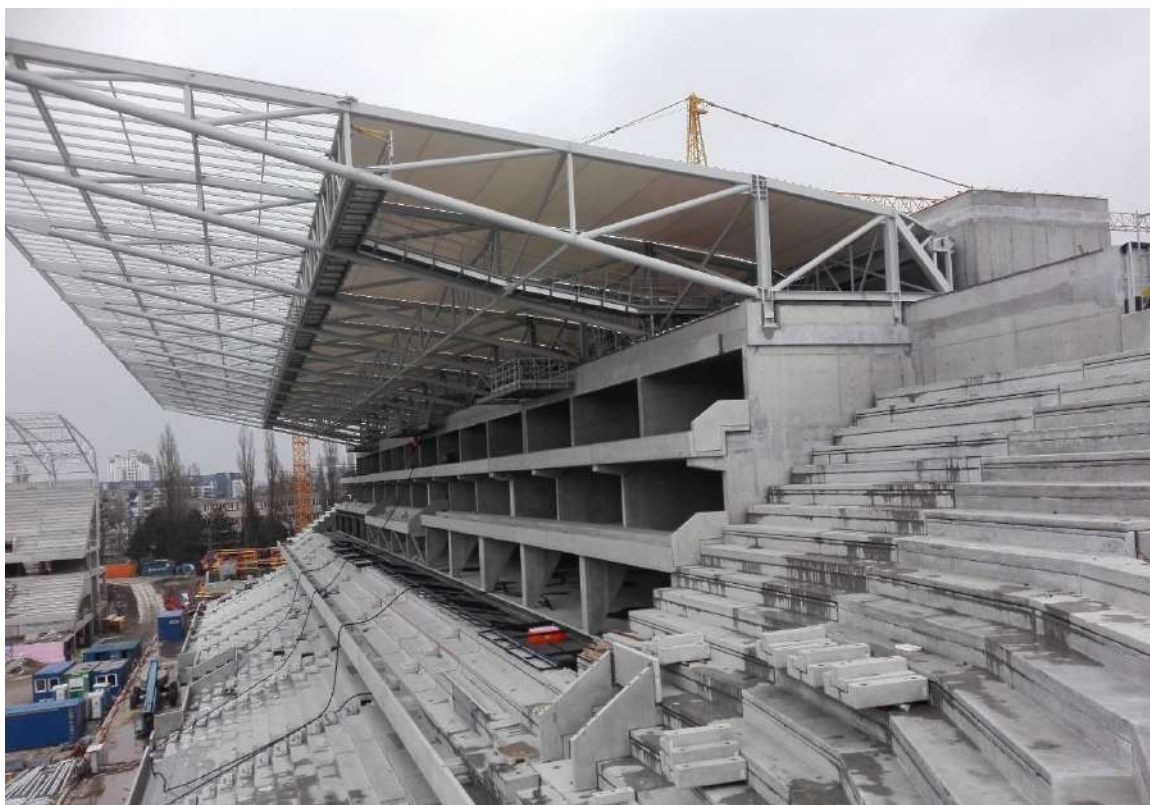
**Fig. 7** Assembly of the structure of the western tribune and tribune benches.

The first outermost row from the grandstand and on the gallery has the shape of an unequal-armed letter U due to the creation of the railing border. The uppermost row of benches is supported by a prefabricated railing brace. To better ensure watertightness, the joints of the benches are placed in the upper position of the seats, with placement on a rubber sealing profile in the insertion groove. Statically, the benches act as hinged, simple beams with the possibility of deformation due to temperature effects. The material used was: concrete STN-EN 206-1-C40/50-XC4, XF1(SK)-CI 0.4-Dmax16-S3.

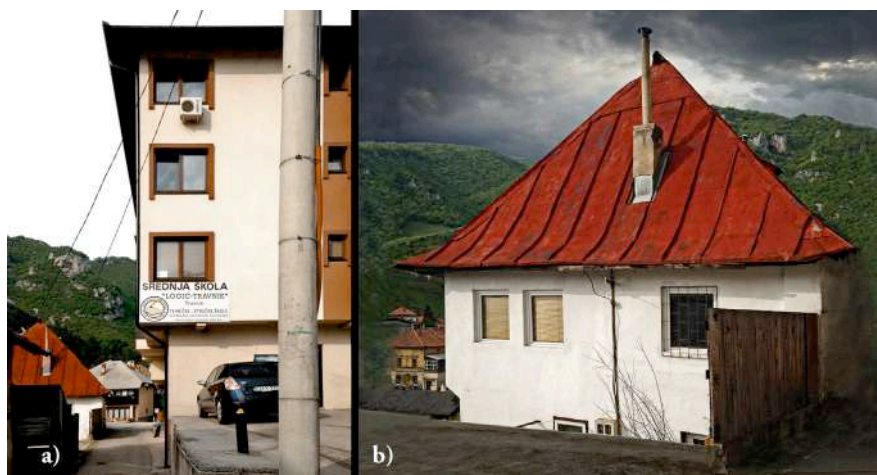
**Fig. 4.** *An inappropriate modern intervention in a historical setting. a) High school in Osoja where one of the traditional residential houses in the Osoja settlement is visible on the left. b) Traditional residential house in the settlement of Osoja. Status recorded in May 2014.*

Although it would be possible to discuss the appropriateness of the construction of typical residential buildings in the 60s last century, which do not interpret the established legalities of building an old Bosnian house into a modern architectural language, but almost completely take over the form, with such detail in the construction that we get confused about the time of creation of these buildings. It can be said that recent interventions degrade the environment to a much greater extent due to the neglect of the spatial relations of the traditional matrix.

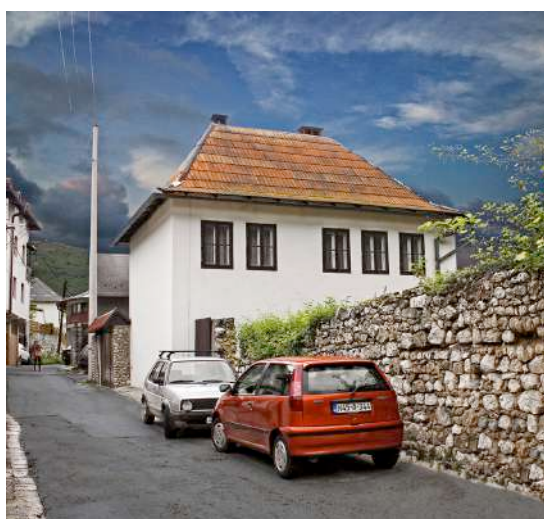
**Fig. 5.** *One of the typical buildings built using traditional building principles. Status recorded in May 2014.*

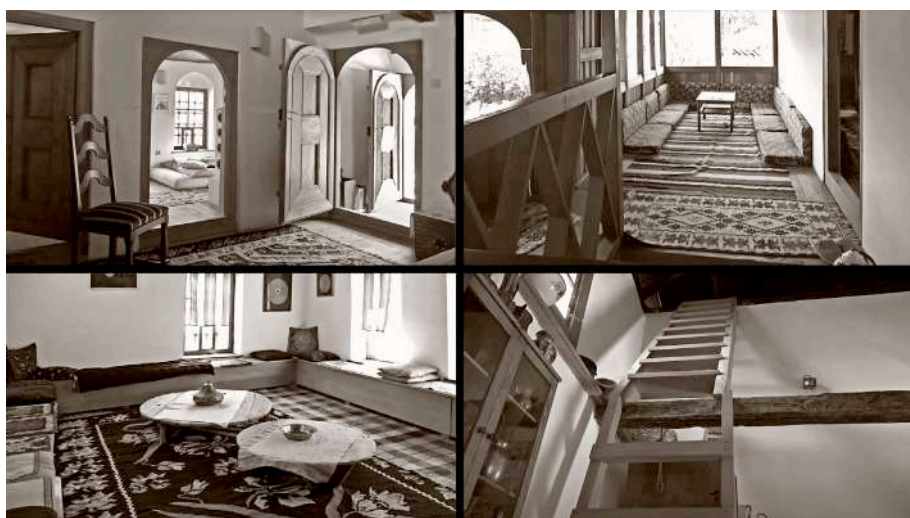
**Fig. 13.** Part of the interior of a restored *čardaklija*, built before 1840, near Travnik. a) view from the *hayat* (hallway on the ground floor); b) *divanhana* (spacious entrance hall on the first floor); c) large room; d) *basamci* (staircase).

Although, most likely due to the later creation or changes made in the interior, the houses that we approached in the interior did not have an open hearth. However, constructive values are visible that continue from the ground floor to the first floor and then take the smoke to the attic space that serves as a drying room. A semi-underground warehouse is present on all buildings – the availability of stone as a material and the slope of the terrain made it possible to raise the ground floor of the building by creating a storage space and possibly keeping small livestock.

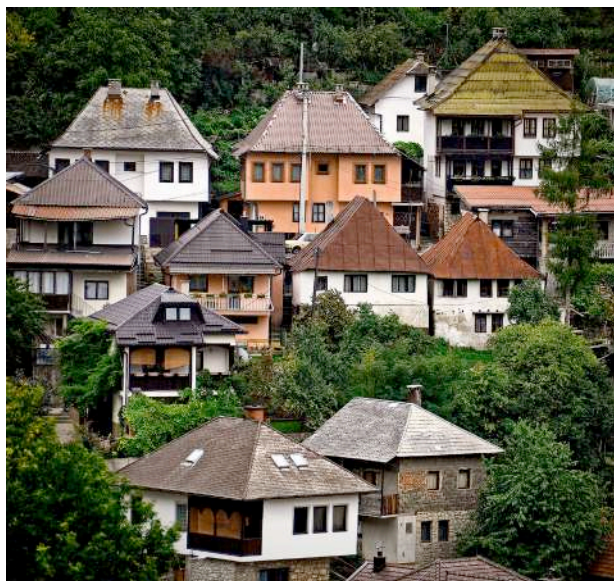
**Fig. 16.** The steep slope of the terrain and orientation of the houses towards the north realizing the right to a view, which is one of the basic design principles here.

Encountering the problem of orientation of the hillside part towards the north, the builders responded in the best possible way. As the achievement of optimal sunlight is prevented by the steep slope to the south, the house is completely closed to the south. While all rooms for living and staying are oriented to the north, realizing the right to a view, which is one of the basic design principles here. Also, the steepness of the terrain made it impossible to realize the intimacy of the open spaces within the courtyard. These conditions were optimal for the undeveloped layout and closed floor plan – one of the characteristics of the *dimalučara*.

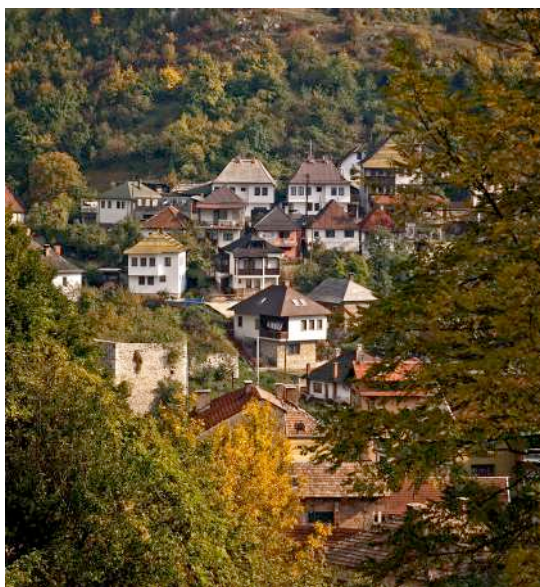
**Fig. 17.** Typical 'mahala' (city District) - scene Osoja. One-story residential building with a southern facade facing a greater slope.

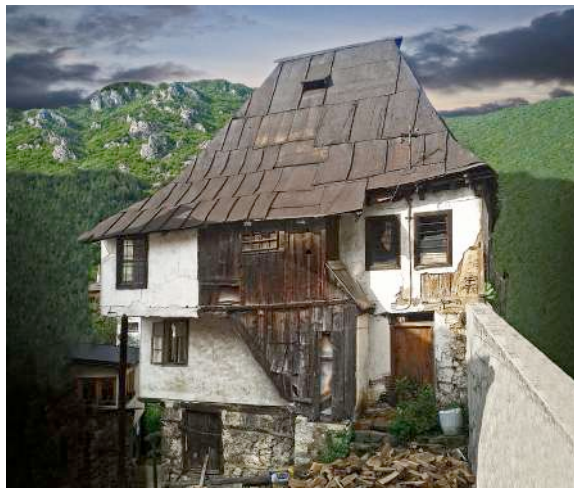
Fig. 18. The building is located in Donje Osoje street, built in the Ottoman period. View of the entrance (western) facade. Condition of the facility in 2014.

The south wall of the floor is perceived as a street facade. The facade is completely closed and originally turned into a low wall made of roughly pressed tufa blocks to the west and east. Meanwhile, the western wall has completely disappeared – in its place today there is a low concrete sub-wall, while the eastern wall is partially preserved.

The entrance to the building is located on the western side of the building, at ground floor level. The entrance is accessed from a stone landing to which several stone steps lead. On the same side, from a lower level, you can also enter the storage space – *magaza*. The north side of the building opens completely towards Lašva and the garden, which originally descended all the way to the river, with a jutting *divanhana* (spacious entrance hall) on the second floor. Such an extraordinary original location of the building, the harmonious relationship between built and natural environment, has been completely destroyed today by the construction of a more recent building in the northern part of the complex, on the river bank.

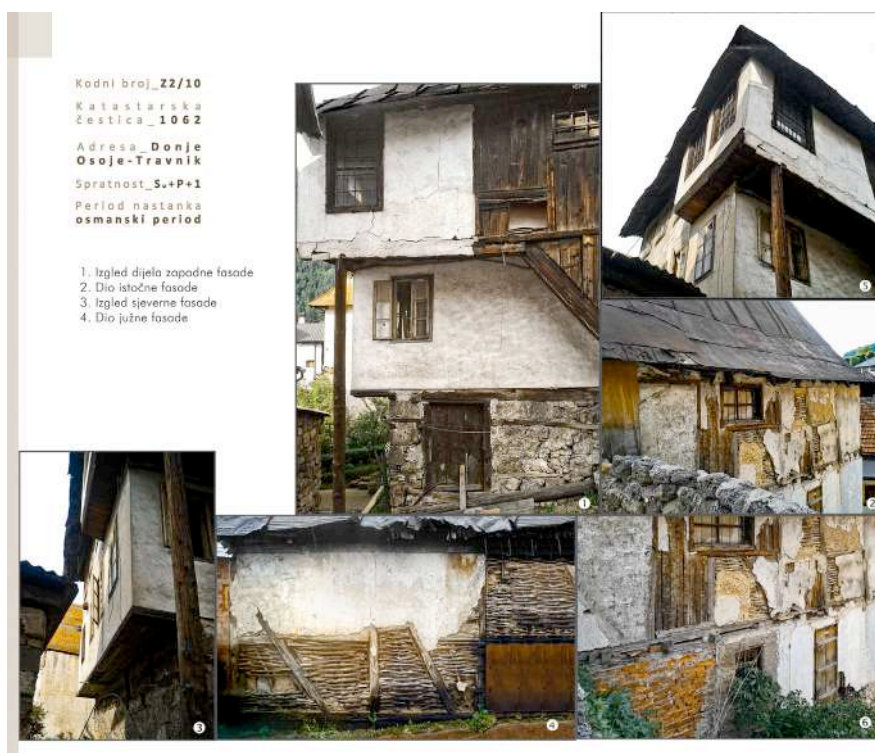
**Fig. 20.** Record card of the building on cadastral parcel 1062. - the building is located in Donje Osoje street.

1) Entrance to the warehouse - part of the western facade; 2) Street view of the eastern facade; 3) Appearance of the northern facade; 4) Street (southern) facade; a complex system with infilling made of horizontally and vertically braided undergrowth; 5) appearance of the northwest facade; 6) He structure of the eastern facade.

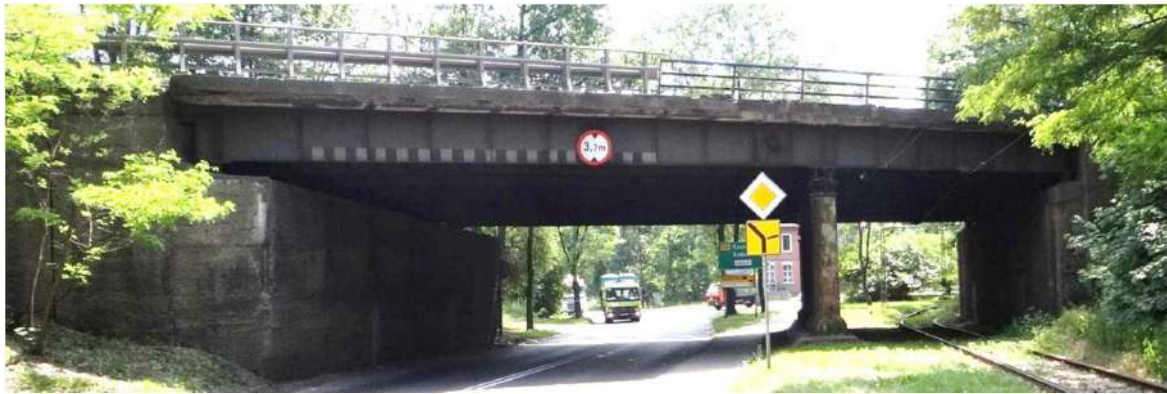
Fig. 1 The considered viaduct seen from the side of Tarnopolska Street.

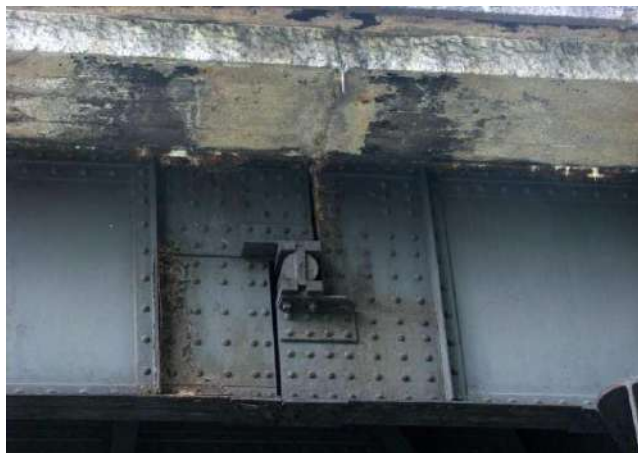
Fig. 5 Riveted construction of a hinge within the main girder.

The main girders are designed here as the continuous beams with hinges located in the longer spans, near the central supports (Figs. 3 and 5). The decks of both bridges are made of 8 mm thick concave steel sheets filled with concrete. Moreover, each bridge is built of four main girders with a spacing of 2.20 m (Fig. 4). The height of such girders varies in their length, which is achieved thanks to the use of thickening overlays on their lower flanges, located in the middle parts of the longer spans. The axial spacing of the girders which are adjacent to the longitudinal dilatation separating two parallel bridges is equal to 1.123 m (Fig. 4).

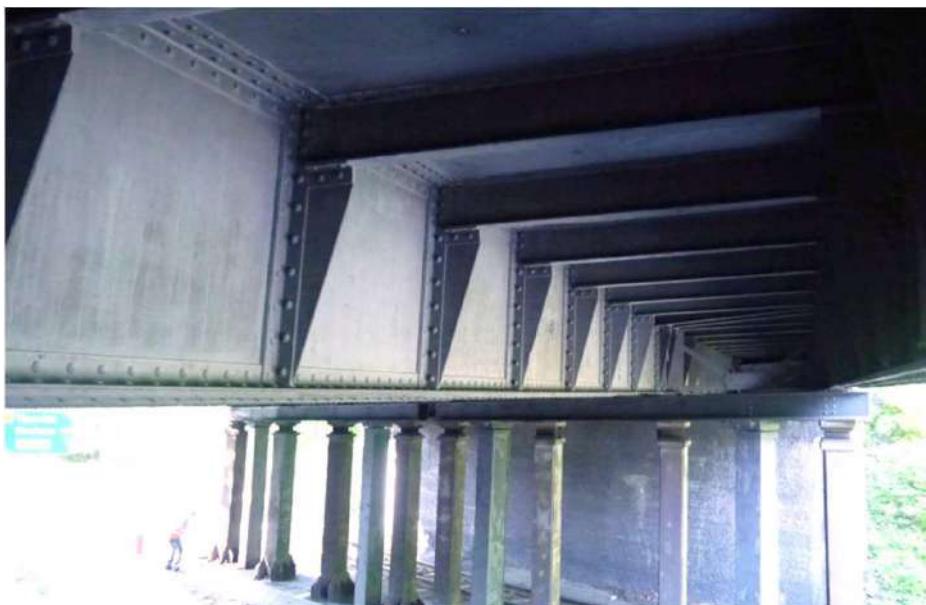
Fig. 6 Construction of the intermediate support of the viaduct (The cross beam crowning the row of steel pillars is noteworthy. The ribbing of the main bridge deck girder is also visible in the foreground).

The massive, non-reinforced concrete abutments with wing walls are used in the viaduct as the end supports (Fig. 3). The intermediate support is in this construction a single row of 12 separated steel columns with a closed box cross-sections (Fig. 6). Among these supports 8 columns, those located directly under the main girders, have a cross-section of 300×600 mm, while 4 additional supplementary columns, those located between the ones previously mentioned, have the cross-sections of 380×400 mm. These smaller columns were probably added to the original structure significantly later to strengthen the weaker pillar erected earlier. All the columns used in this support were finally effectively fixed in a single massive concrete foundation slab.

The riveted steel plate girders with a web size of 1100×10 mm constitute the bridge deck supporting structure. The webs of these beams are stiffened with transverse ribs (Fig. 6). The hinge is located in the longer span of such beams, at a distance of 1600 mm from the axis of the bearings placed on the intermediate supports, and consists of a steel roller with a diameter of  $\phi 140$  mm and also of a suitably shaped plate web, reinforced with sections of 150×100×10 angles horizontally arranged (Fig. 5). Both the lower and the upper flanges of the plate girders are made with the use of 90×90×10 mm isosceles angles, placed on both sides of the web and connected to this web by riveting. The lower flanges of the girders are strengthened, only in the middle part of the longer span, in the case of two external beams with a single while in the case of the remaining girders with a doubled overlays of the size of 200×12 mm. The upper flanges of such beams are also strengthened, in this case along their entire lengths, with a steel overlays of the size of 300×12 mm. The total height of the

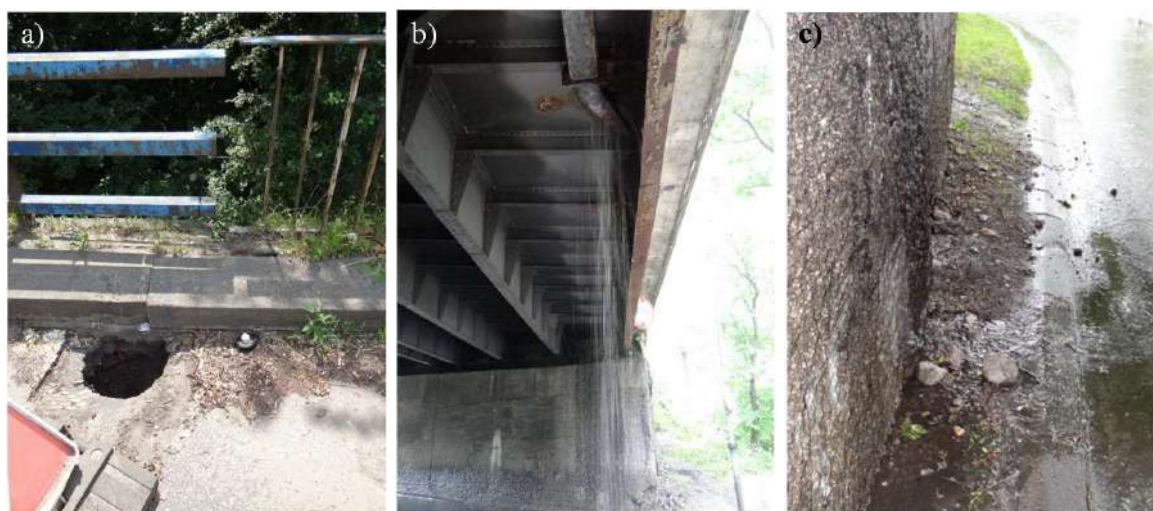
Fig. 7. Deficiencies in the viaduct drainage system, including: a) the lack of the protection of the drainage pipe, b) effects of a blocked drainage system, c) rainwater running down the abutment.

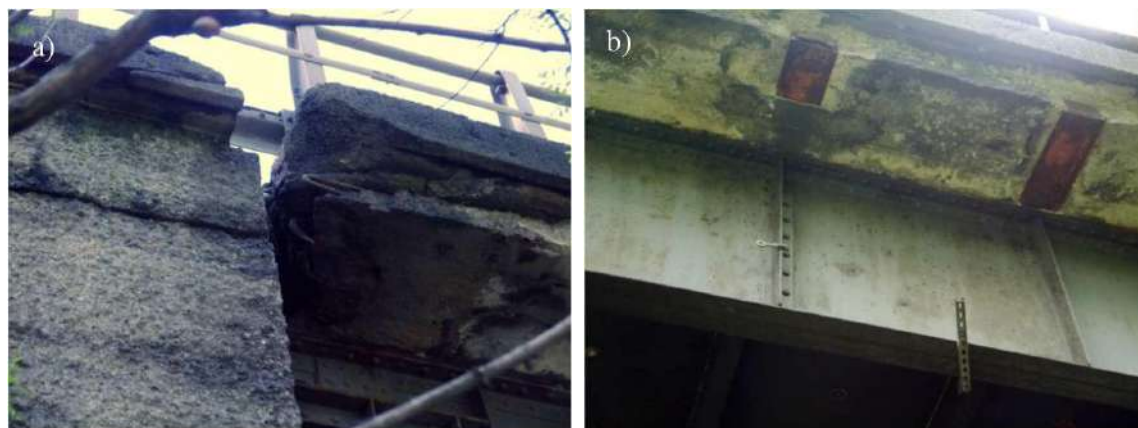
Fig. 9. Damages to the deck slab identified in its cantilever part, including: a) missing a piece of the deck in the vicinity of the abutment, b) corrosion of steel beams exposed to weather conditions after the concrete cover has fallen off.

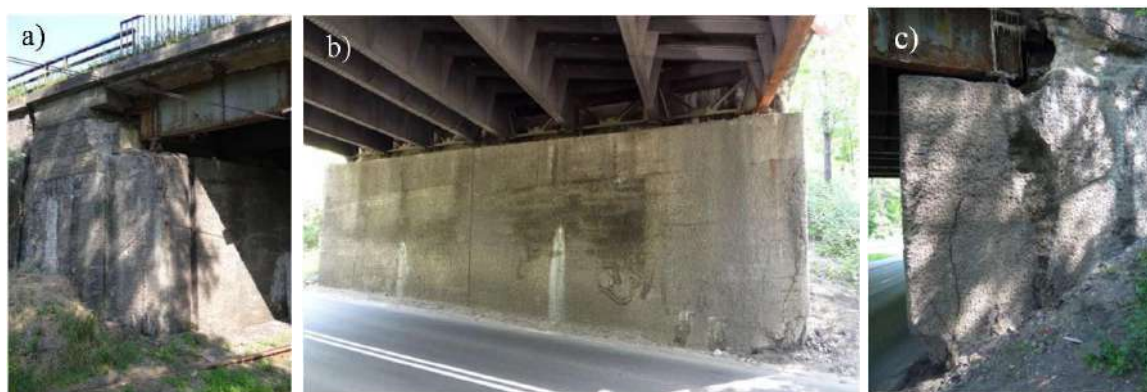
Fig. 10. Damages to the viaduct abutments (description in the text).

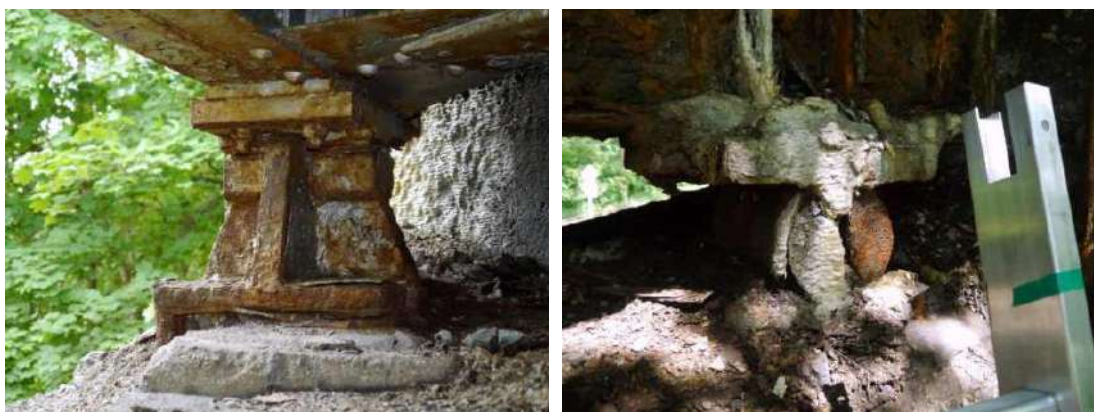
Fig. 11. Bearing corrosion inventoried under the outer girder.

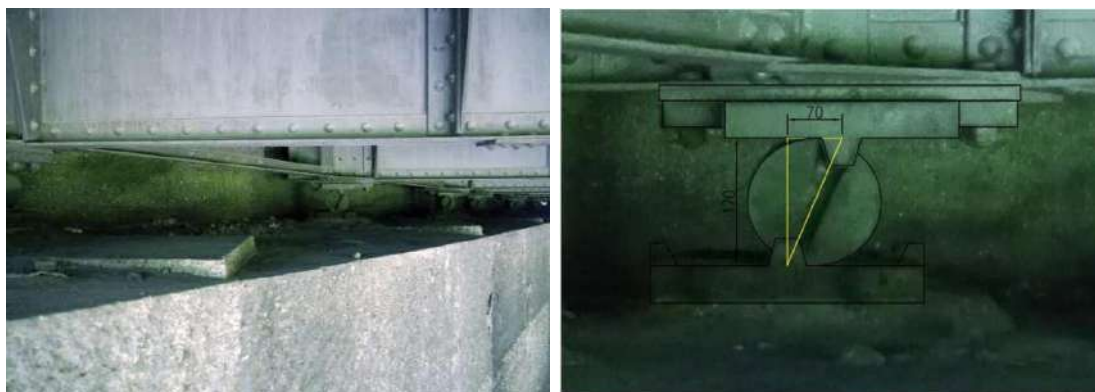
Fig. 12. The extreme deflections of the bearings observed at the abutment of the longer span.
