**ДОКЛАДИ  
МЕЖДУНАРОДНА НАУЧНА  
КОНФЕРЕНЦИЯ  
ПО ОПАЗВАНЕ  
НА  
НЕДВИЖИМОТО КУЛТУРНО  
НАСЛЕДСТВО  
БАНИ' 2022**

**PROCEEDINGS  
INTERNATIONAL SCIENTIFIC  
CONFERENCE  
PRESERVATION  
OF CULTURAL HERITAGE  
BASA' 2022**

| <b>стр. 282-306</b> | SEISMIC DAMAGE OF BUILDING STRUCTURES AND THEIR REHABILITATION<br><b>Radomir Folić, Miloš Čokić, Boris Folić, Angelos Liolios</b> |

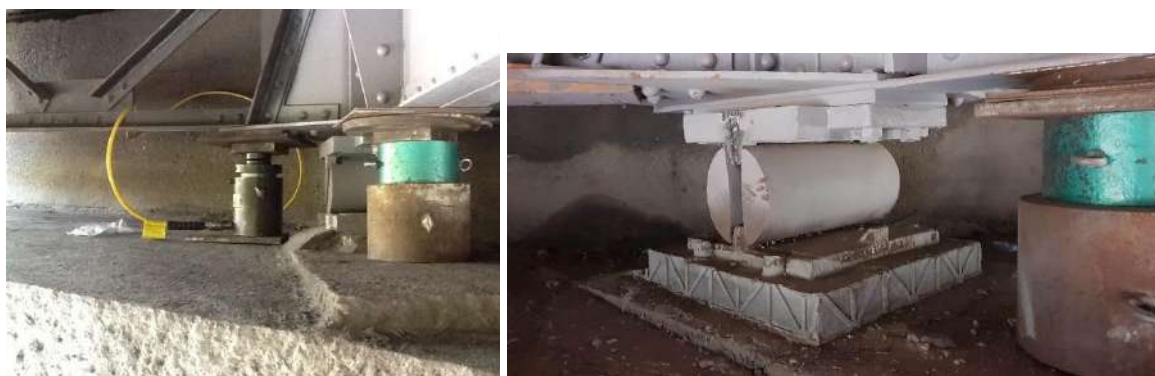
Fig. 15. The repair details of the support bearing, including: on the left - temporary lifting of the bridge deck by means of the hydraulic actuators, on the right - shifted bottom plate of the bearing with a new bearing pad.

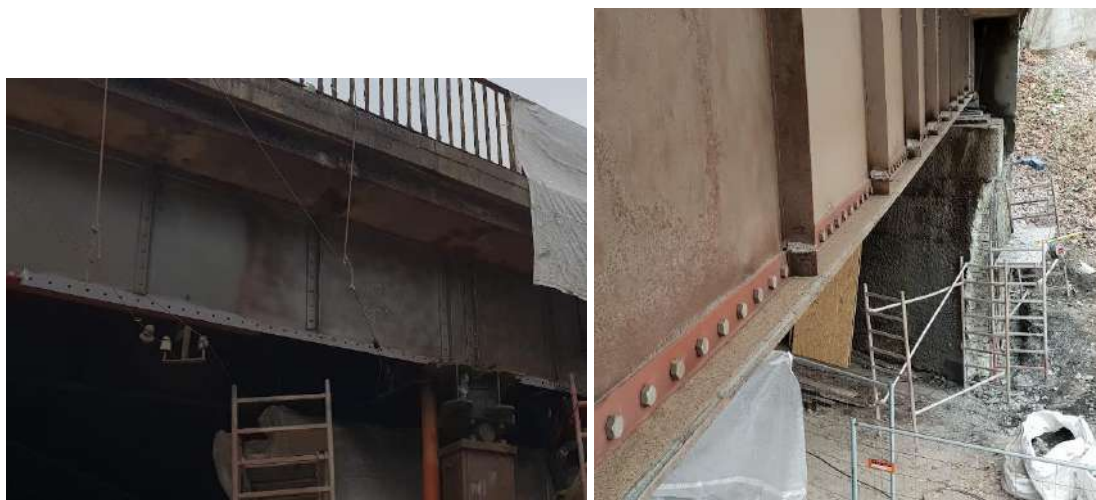
Fig. 17. The girder number 8, including: on the left - condition after removing the angles and the sheets forming the bottom flange, on the right - condition after inserting the new angles and the new bottom flange.

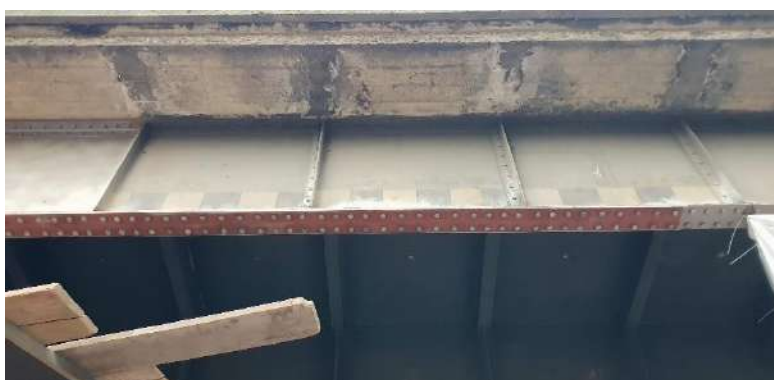
Fig. 18. The strengthening of the bottom flange used in the girder number 1.

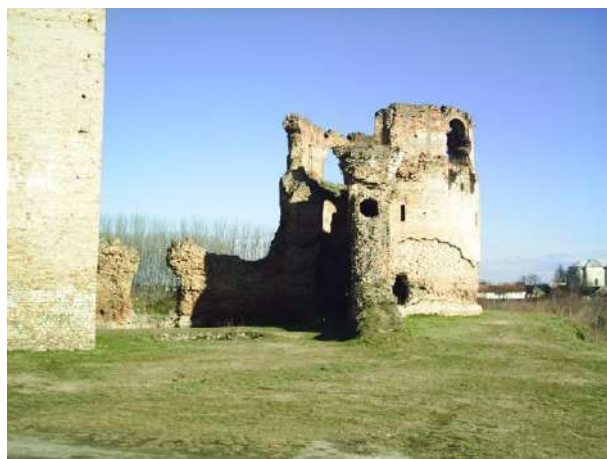
**Fig. 2: The tower as practical example of minimum intervention before works (photo by Nedeljko Markovic)**

This is undoubtedly an example of the application of the principle of minimal intervention because the decision of the experts defines the way in which the integral of the original shape of the tower is preserved, which allows observer to imagine the appearance. This approach is completely in line with the initial decision of the experts to have the museum presentation of the Bač Fortress (Fig. 2, 3).

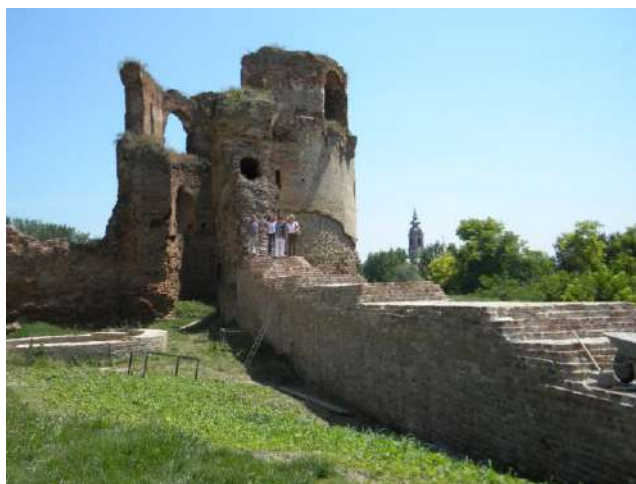
**Fig. 3:** The tower of Bač as practical example of minimum intervention after works (photo by Nedeljko Markovic)

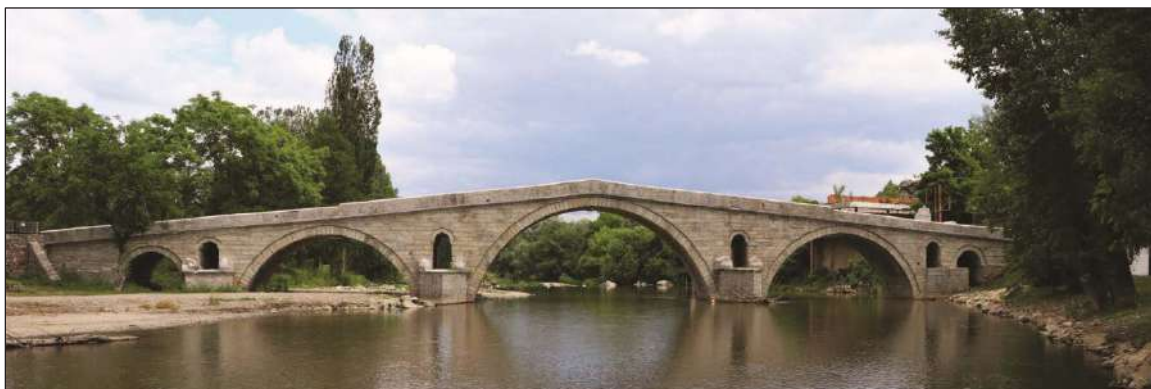
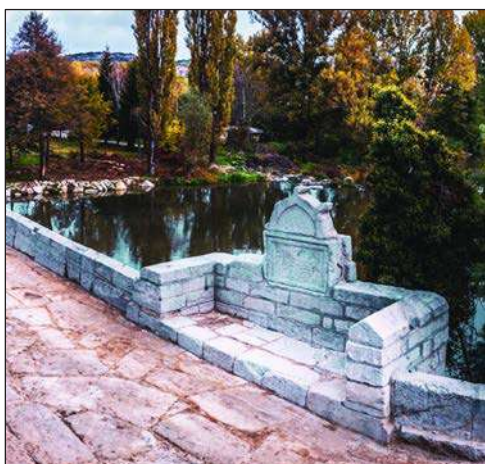
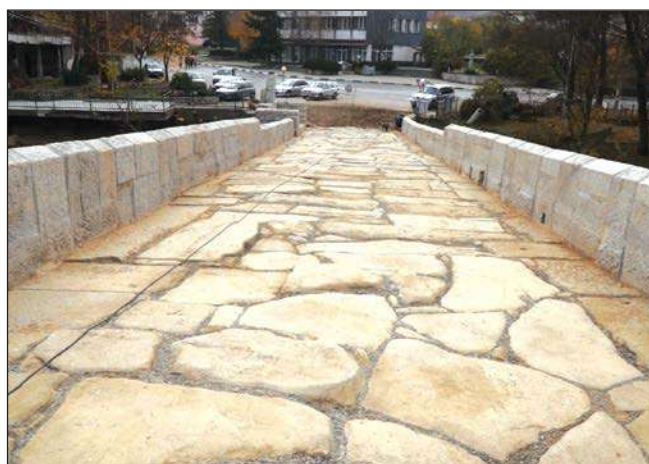
Kadiyski (Kadin) Bridge over the Struma River in Nevestino settlement, Kyustendil region, 1469/70. General view and details from the tarich and original road pavement

Kadin bridge is constructed over the Struma River, according to his kitab, by the Islamized Christian Ishak Pasha (Turkish - Inegöllü İshak Paşa) during his first mandate as Grand Vizier to Sultan Murad II in 1468/9 – 1471/72. [2] This bridge is the first of his charitable public works in Europe. During excavations that lasted from 1904 to 1906 in the neighboring region of Moshteni, Yordan Ivanov discovered the remains of an ancient stone bridge connecting neighbourhoods of a large settlement on the banks of the river. One of the two parallel routes of the road from Constantinople - through Plovdiv, Belovo, Kostenets, Cherven breg and Kyustendil to the Adriatic, passed through here. [3]

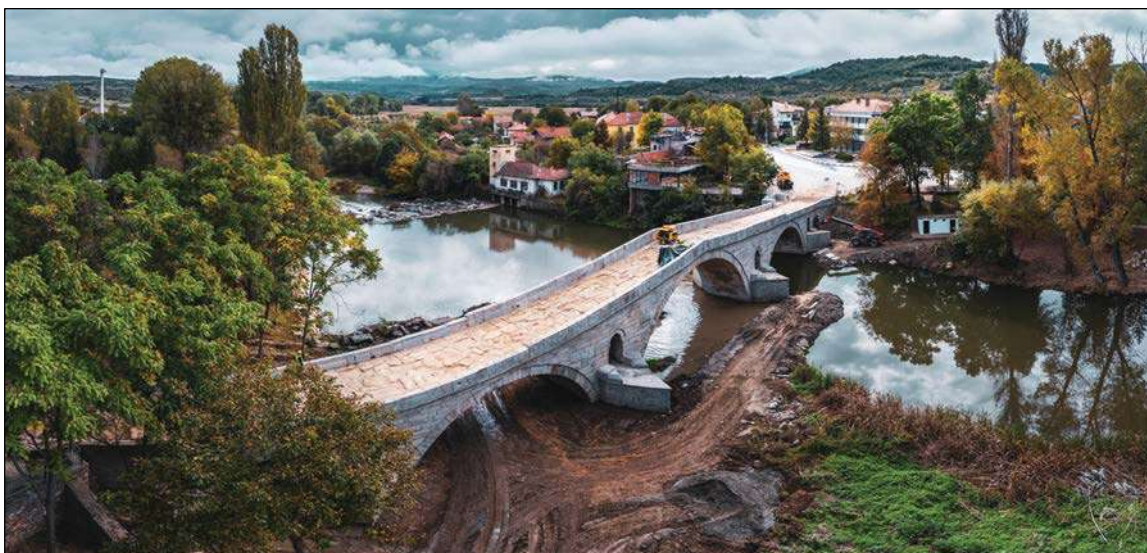
Photogrammetric façade plan of Kadiyski (Kadin) Bridge – NINCH archive; view from the bridge during restoration activities in 2020

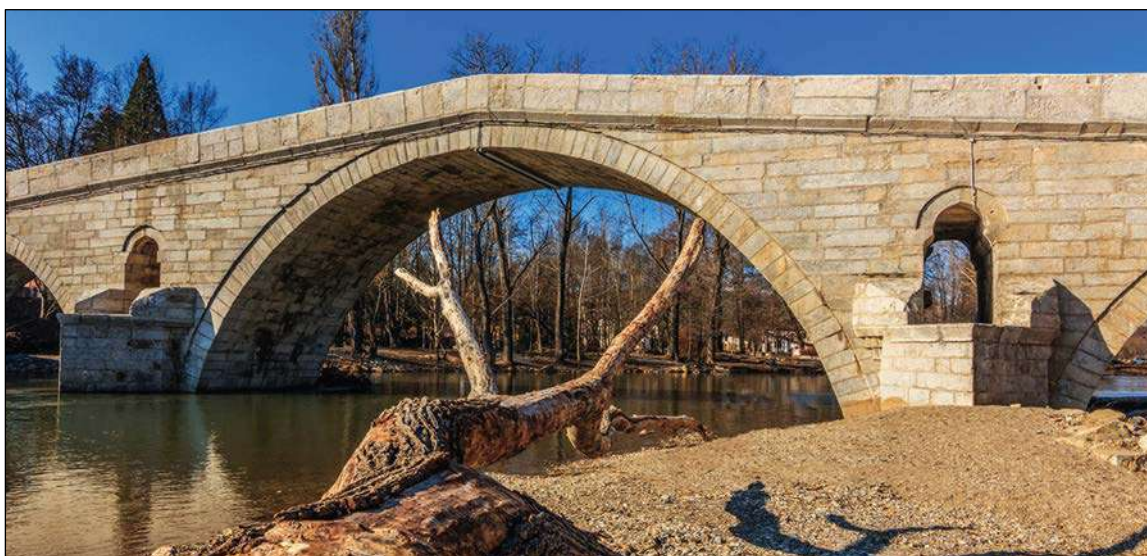
Fragmentary view from the central part of the hull of Kady Bridge with the specific vaultings and clogging protection of the relief openings

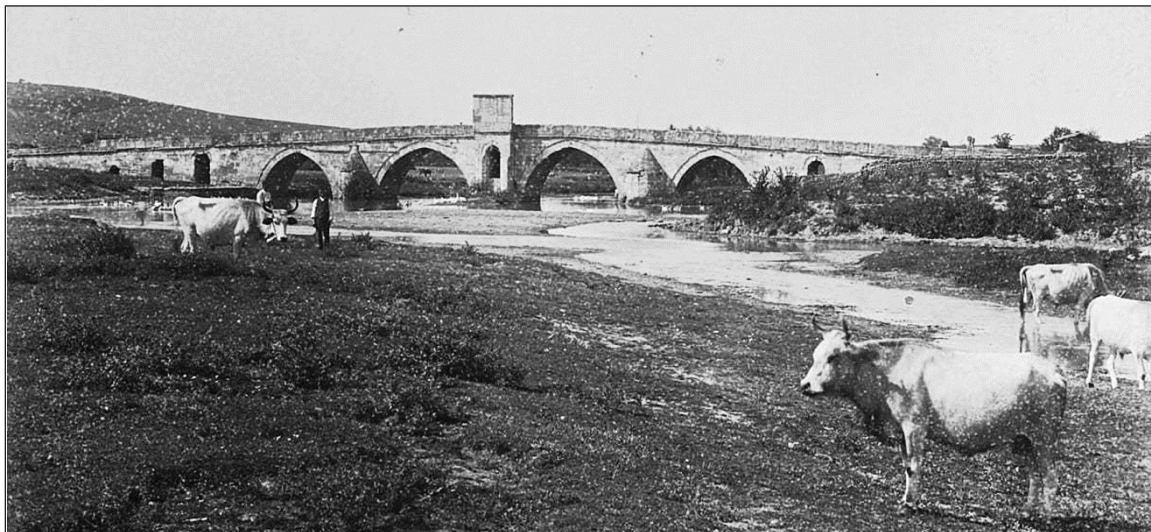
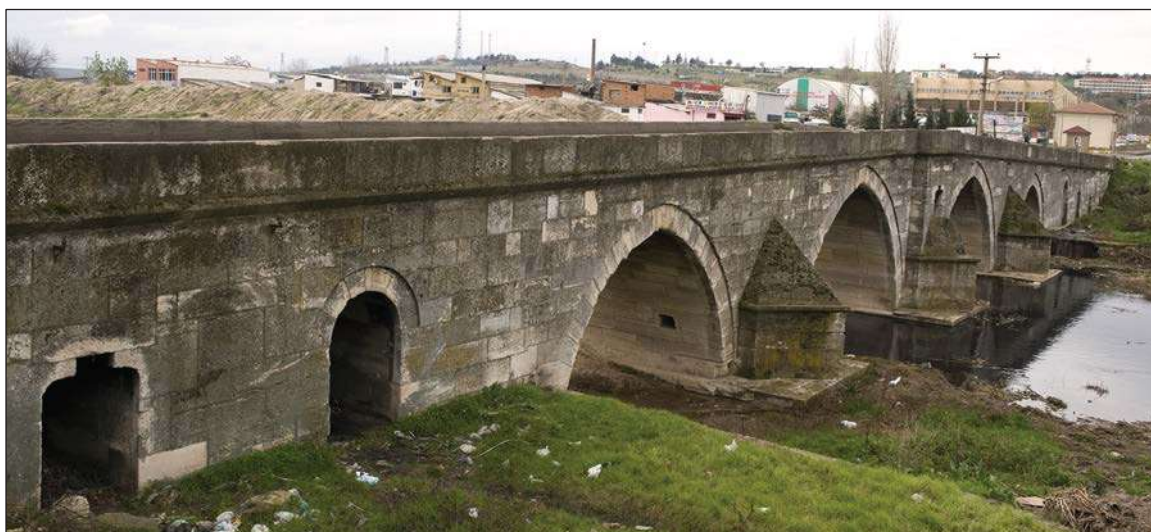
Sokullu Mehmet Paşa Bridge (15th century) in Luleburgaz, Kırklareli province (Bulgarian name – Lozensgrad). Photographic views from the end of 19th century on a marked superstructure plan by Bozkurt (1950), and current condition

The Lüleburgaz bridge, according to Orhan Bozkurt, is 92.60m long and 6.05m wide, with 4 large arches, the central ones being 8.70m and 8.60m wide. However, it also has six small side lower shore breaks and one relief opening above the central breakwater. Of these, four small vaults and the relief opening architecturally belong to the typology of the relief openings from Kadin Bridge. In addition, at the Lüleburgaz bridge, in an identical way, on both sides of this opening, above the breakwater, similar to the bridge over the Struma, stone pyramidal sides, directing the water outflow, step over the breakwater. (6c) Thus, all these identical elements lead to the conclusion that the bridge at Lüleburgaz (nowadays in the centre of the grown city) was most likely built by the same artisans who constructed the facility over the Struma River near Kyustendil. Therefore, the Lüleburg Bridge can be dated like it to the second half of the 15th century.

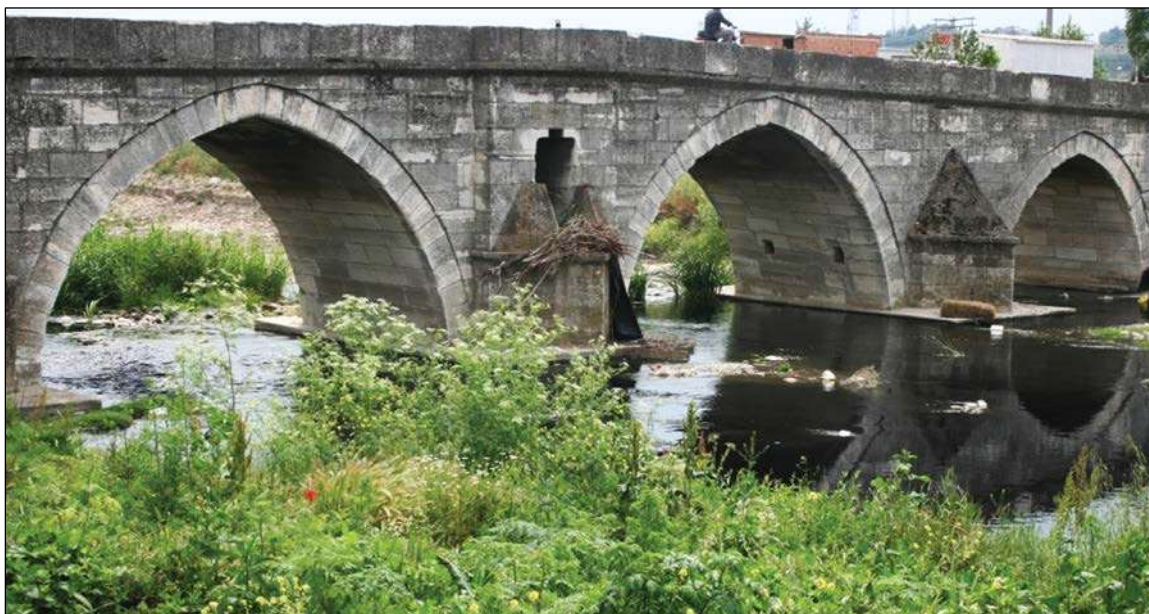
Sokullu Mehmet Paşa Bridge (15th century) in Lüleburgaz, Kırklareli province (Bulgarian name – Lozengrad). Photographic views from the end of 19th century on a marked superstructure plan by Bozkurt (1950), and current condition

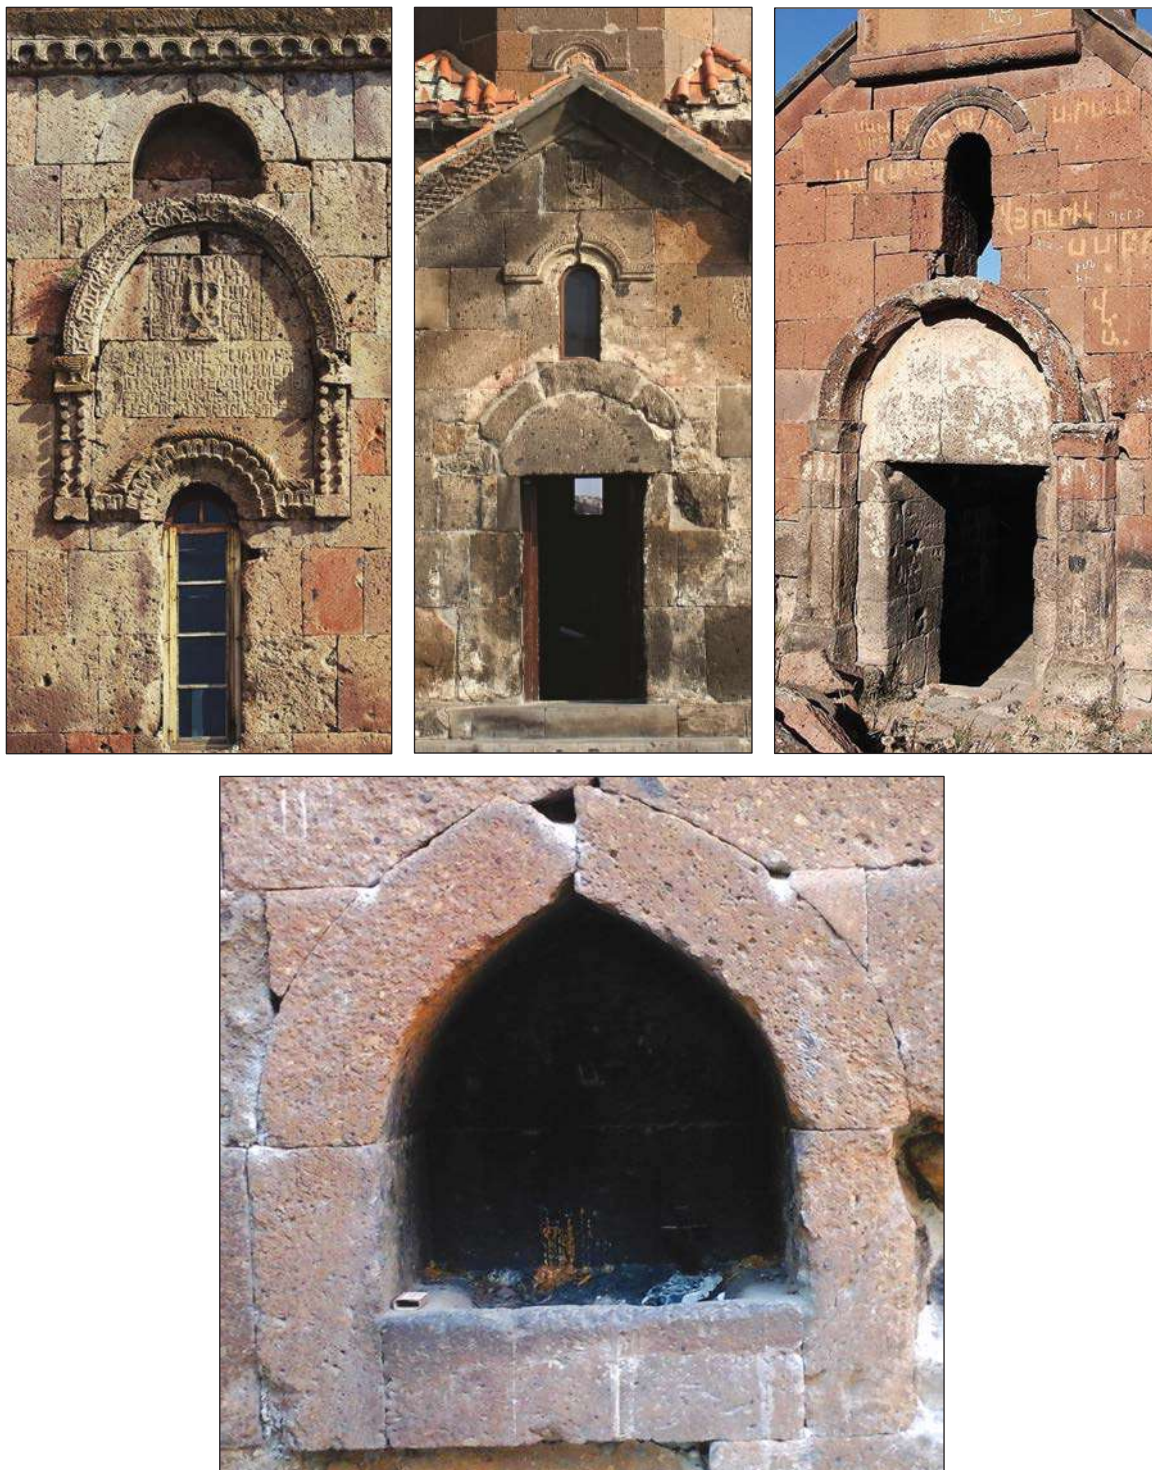
At the same time, in Armenian architecture since the 5th - 6th centuries, the practice of installing precisely carved stone forms on the facades, made of one or two segments connected at the zenith on the smaller vaults, was present in the same way as it is at Kadin Bridge.

Armenian vaultings constructed with large curved elements – St. Joan church in Mastara village, Argatsotn province (5th century); the White church in Ashtarak, Argatsotn province (VI century); the Red church in Ashtarak, Argatsotn province (7th century); Artavasik church near the village of Burakan, Argatsotn province (730 – 740)

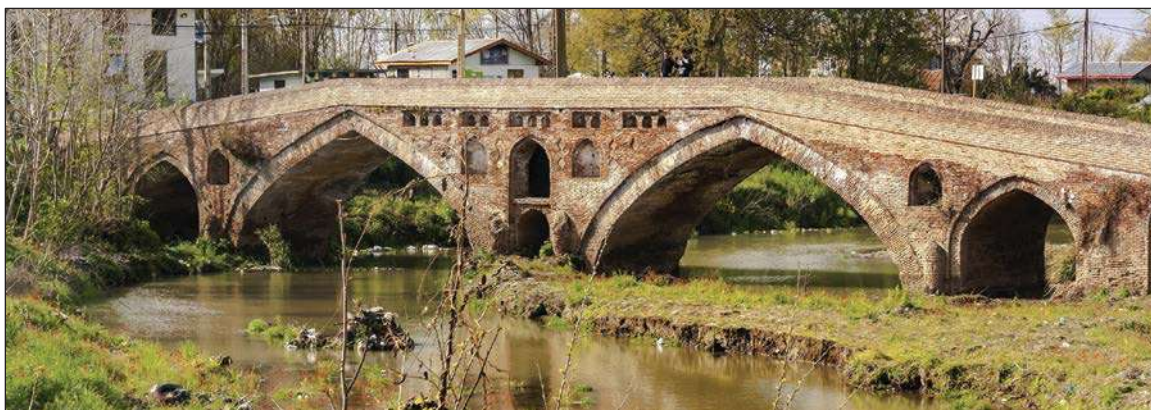
The Iranian brick bridge Pol-e Tamijan (1354/5) over the Tamijan river near Rudsar village, Gilan province, Iran

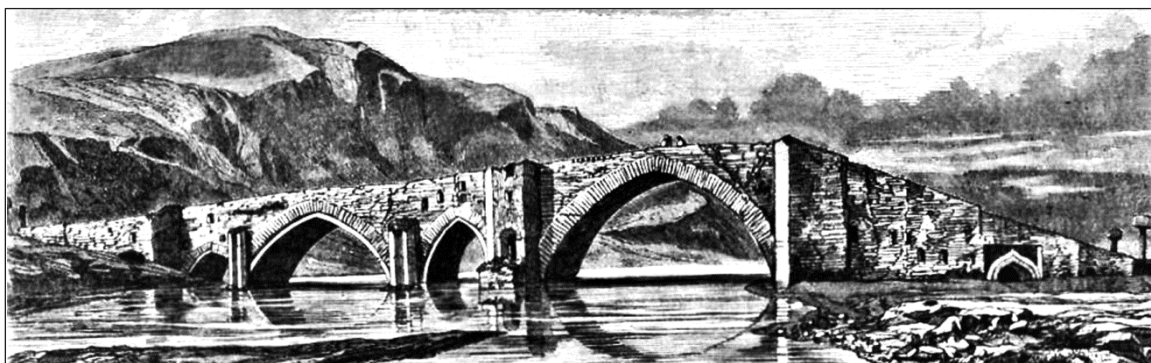
The Azerbaijani Red bridge (Qırmızı Köprü, Sınıq köprü – The broken bridge, 12th century, reconstructed in 1647) over the Efram river (Georgian – Hrami) near Julfa, Lower Kartli (Azerbaijani – Nahicevan)

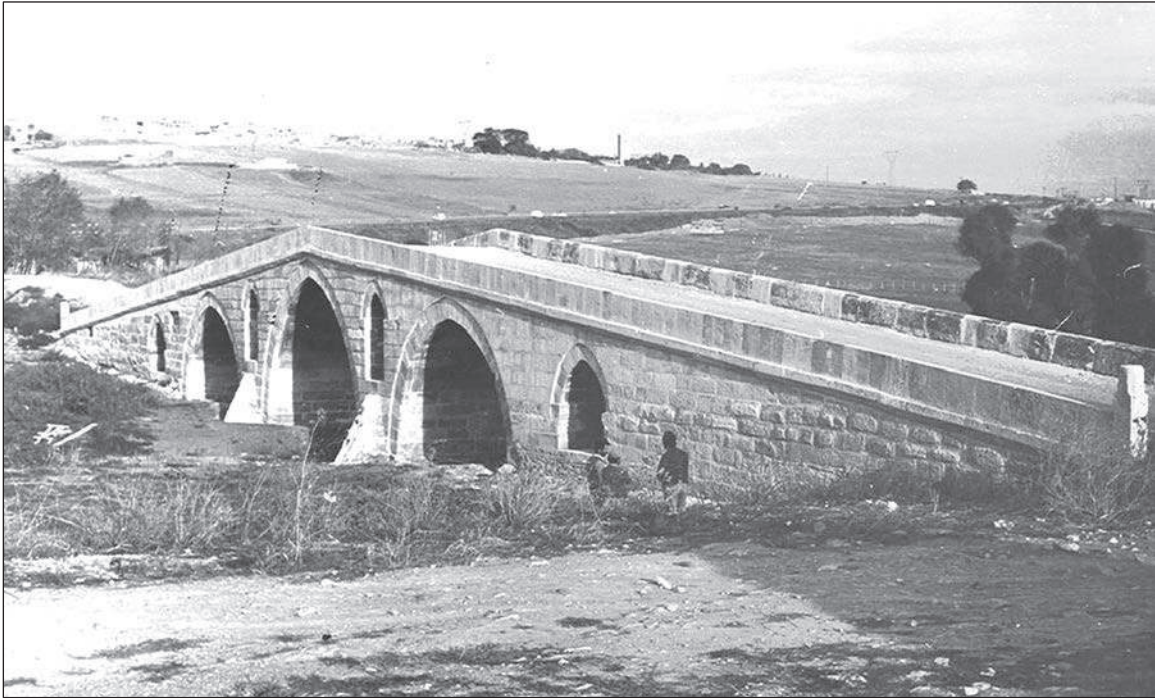
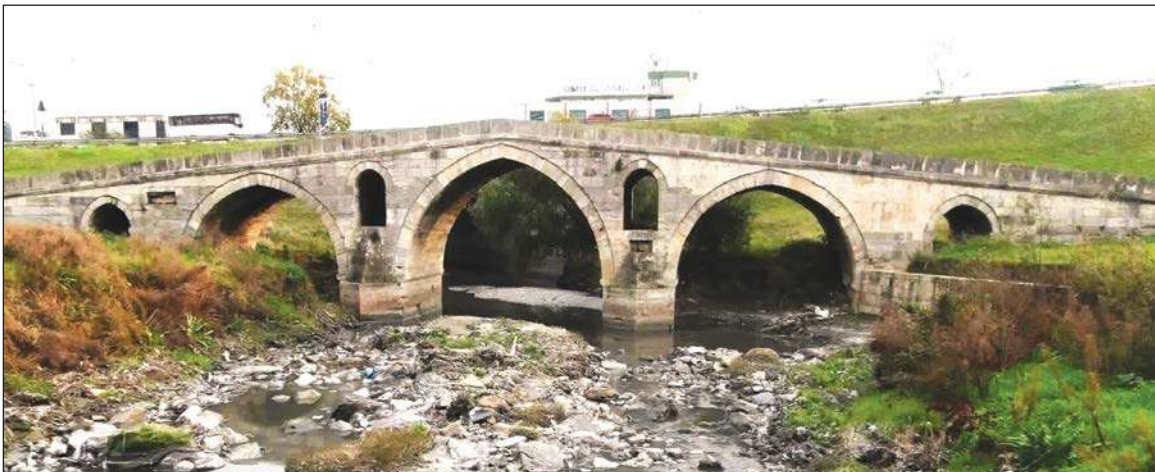
The same molding is later placed on the Byzantine bridge over Harâmidere (Harâmidere Köprüsü) later known as Kapı Ağası Köprüsü (or Yakup Ağa Köprüsü) on the Constantinople Road between the Küçük- (6th century, between 867 and 886, 1455, 1498/9 etc.) and Buyukcekmedze bridges. The bridge being of Byzantine origin is evident from the brickwork of the oldest arches, so it is wrongly assumed that this is a newly built Ottoman bridge. In this case, there is a renovation by the Ottoman administration in the time before the construction of the two big bridges (one of which – Büyükçekmece, is the work of Sinan), i.e., it was carried out before 1568. [6] However, its architectural features suggest that it was done much earlier, most likely in the second half of the 15th century,

The Haramidere bridge (Harâmidere Köprüsü, Kapı Ağası Köprüsü, Yakup Ağa Köprüsü, 6th – 7th centuries, renovated circa 1455 and reconstructed circa 1560 by mimar Sinan) over the Haramidere river, Beylikdüzü district, Istanbul

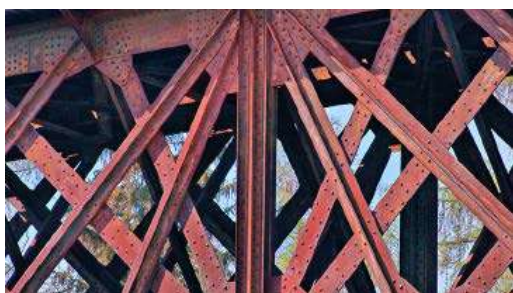
Fig.3. Details of riveted bridges – Mokropsy[20]

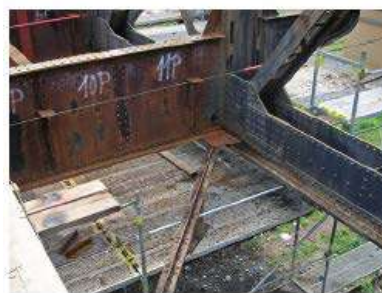
Fig. 19. Truss joint with double-walled lower chord[20]

Fig. 18 shows an example of a joint with a single-walled lower chord. Figure 19 is a photo of a member joint with a double-walled lower chord. An examination of the structural design of riveted truss bridges shows that there is a large amount of variability in the shapes of the girders and the structural design of the individual members and joints. Riveted truss bridges were characterised by their lightness, but also, on the other hand, by the intensive labour needed for manufacturing and assembly. The structural design of early riveted truss bridges contains many details that are difficult to maintain and to restore corrosion protection in the long term perspective.

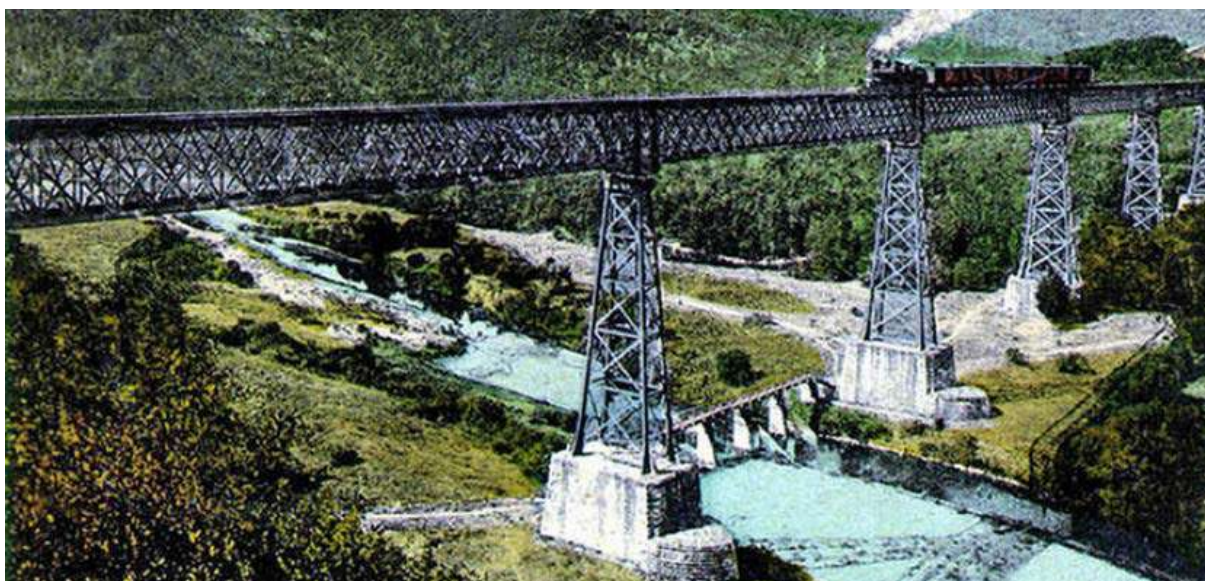
**The oldest steel riveted bridges** in Czechia date back to the second half of the 19th century, the period of railway development. These are mainly railway-carrying truss bridges. An impressive example was the Ivančice viaduct dating from 1870, which was a part of the Ferdinand railway on the route Vienna – Hrušovany nad Jevišovkou – Střelice – Brno over the Jihlava river valley (Fig. 20). After more than 100 years of operation of the riveted viaduct, a new parallel welded bridge was built in 1978. The original bridge was dismantled, leaving only one span as a cultural monument.

Fig. 20. Ivančice Viaduct[20]

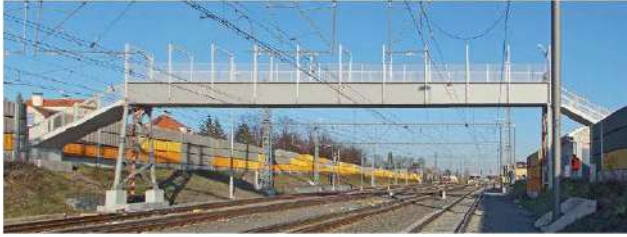
**Fig. 22.** Plate girder bridge with half-through bridge deck (footbridge in Prague Hostivař from 1937)[20]

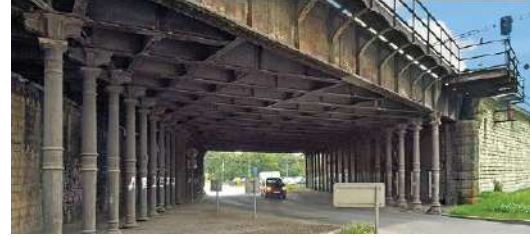
**Fig. 23.** Plate girder deck-type bridge (Křídlovická railway bridge in Brno from 1895)[20]

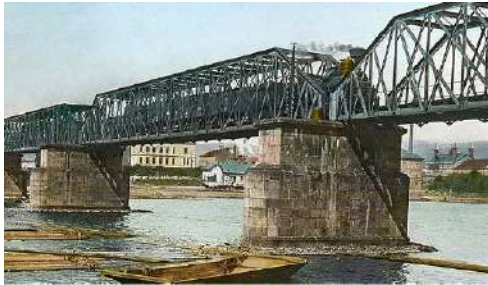
**Fig. 24.** Truss half-through bridge with straight chords (railway bridge in Prague under Vyšehrad from 1871)[20]

From the point of view of rail transport, the 1871 railway bridge below Vyšehrad, which connected the Prague railway stations on both banks of the Vltava River, was important. This truss bridge with parallel chords later became an important Prague landmark. However, the single-track bridge gradually ceased to meet the increased traffic demands, and in 1901 it was replaced by a new double-track truss bridge with an upper parabolic chord. Other important railway bridges from the last quarter of the 19th century include Prostřední Žleb, a bridge over the River Labedating from 1874, which was part of the Austrian Northwestern Railway between the stations of Děčín and Prostřední Žleb. Then there is the 1889 bridge over the Orlík reservoir near Červená nad Vltavou, and the bridge over the River Vltava near Skochovice, which dates from 1897. The oldest steel riveted road bridges were built in the Czech Republic at the end of the 19th and the beginning of the 20th century, e.g.: the bridge over the Vltava in Týn nad Vltavou from 1892, the bridge to Císařská louka over the Vltava arm in Prague from 1901, the Čech Bridge over the Vltava in Prague from 1908 and the bridge over the railway tracks in Prague below Bohdalec from 1915. All these examples of steel riveted bridges, both railway and road, are proof of increasing technical sophistication of the Czech lands during the 19th century.

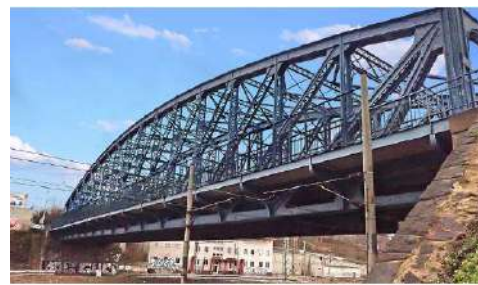
**Fig. 25.** Truss bridge with lower bridge deck with upper parabolic chord (road bridge in Prague-Bohdalec from 1915)[20]

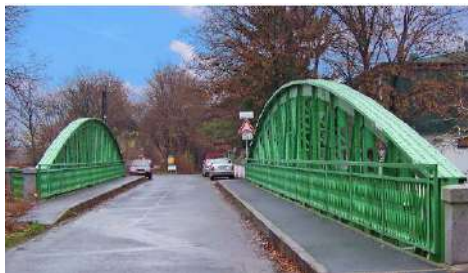
**Fig. 26.** Truss half-through bridge with upper parabolic chord (road bridge to Císařská louka from 1901)[20]

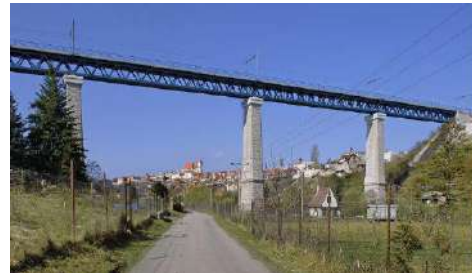
**Fig. 27.** Truss deck-type bridge with straight chords (railway bridge in Znojmo from 1871 and after reconstruction in 2009)[20]

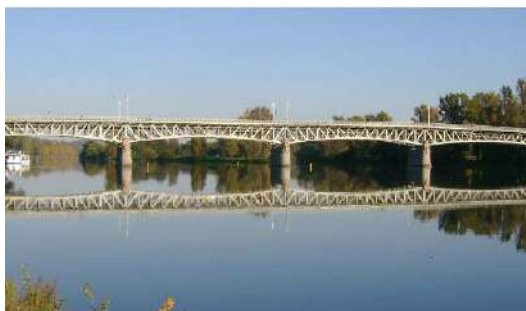
**Fig. 28.** A truss semi-through bridge with variable height of main girders (Gerber beam). (Tyrš road bridge over the River Labe in Litoměřice dating from 1910)[20]

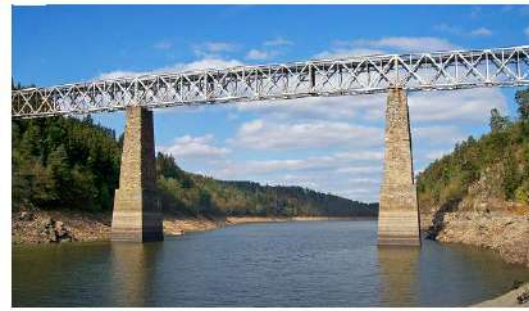
**Fig. 29.** Truss bridge with semi-through bridge deck (Gerber beam) (railway bridge at Červená nad Vltavou from 1889)[20]

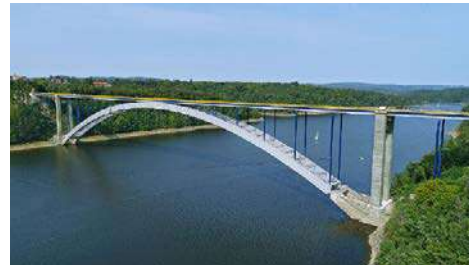
**Fig. 31.** Arch deck-type bridge. Two-hinged plate arches. (Žďákov Bridge over the Vltava River from 1967)[20]

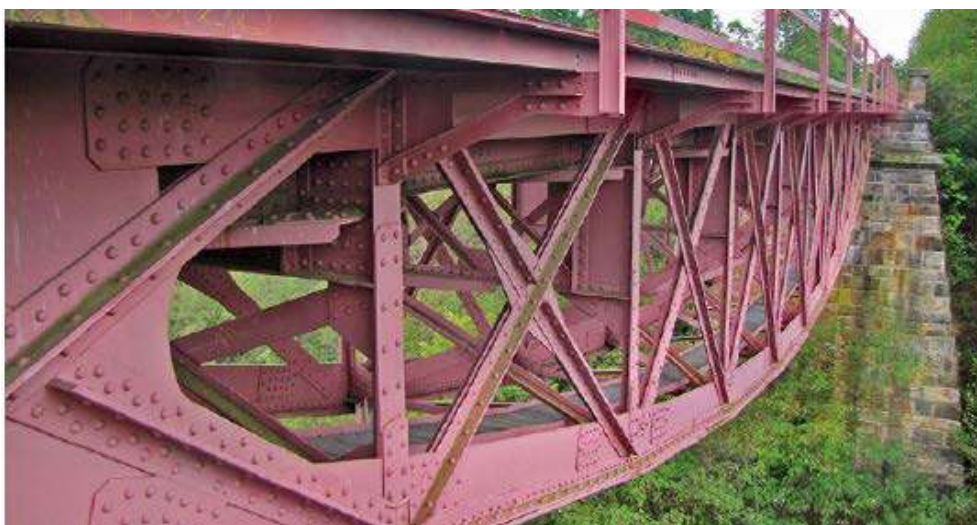
Railway bridge over the Klabava valley. Steel semi-through truss bridge with parabolic lower chord. The bridge has three spans of about 35 m (Fig.32). The truss structure is vertical with crossed diagonals. There is a longitudinal horizontal truss bracing at the level of the bottom chord and under the stringers. There is a vertical transverse bracing in each joint. The chords of the truss are single-web, the upper chord is a T-section, and the lower chord is an inverted T-section. The crossbeams are trussed and connected to the verticals of the main beam. The stringers are I-sections and are recessed into the crossbeams. All members and connections are riveted. The superstructure is supported by steel bearings, the movable bearings have 5 cylinders. The original bridge (of Schifkorn-type) was replaced by the present steel structure in 1892.

**Fig. 32.** Railway bridge over the Klabava valley. Steel semi-through truss bridge with parabolic lower chord from 1892[20]

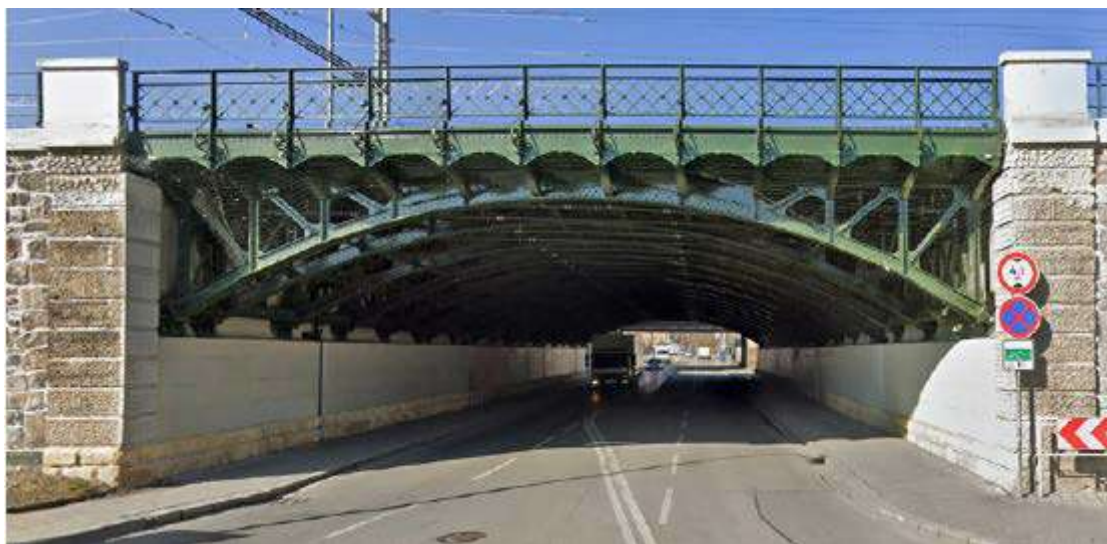
The railway bridge over Hybešova Street has one span of 15.2 m (Fig.33). The bridge consists of four structures lying side by side. It is an arch deck-type bridge. The main girder has 11 sections, the outermost three spans have a trussed vertical structure, and the five sections in the middle have a plated structure. The number of main girders varies from 5 to 6, according to the width of the bridge structure. The distance between the girders is 2.80 m. All the trusses are the same. The height of the girder is 2.70 m in the bearing, 0.50 m in the middle of the span. The main beams are riveted single web. The upper chord has a T cross-section, the lower chord an inverted T cross-section. The diagonals are of segmented members with frame connections. The crossbeams are at an axial distance of 1.5 m, and are plated riveted of cross-section I. In one case, the crossbeams are trussed. The curved metal plates (called “puklovka”) forming the bridge deck are placed on the crossbeams. The transverse truss bracings are located between the three end verticals. For two structures, there is longitudinal horizontal bracing at the upper chords of the crossbeams. The bearing of the superstructures is transversely movable on steel table bearings. The substructure is made of stone masonry. The bridge was constructed in 1897.

Fig. 33. The railway bridge over Hybešova Street with one span of 15.2 m, from 1897[20]

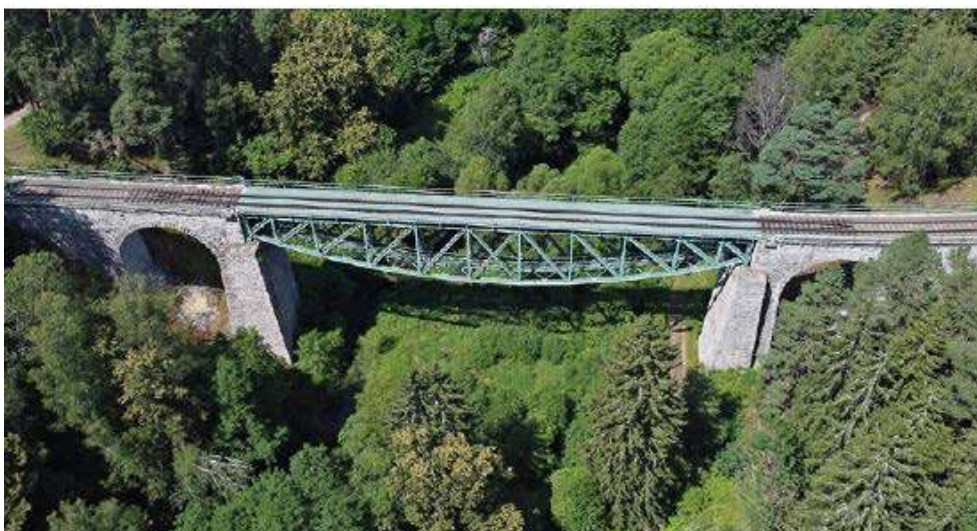
The railway bridge over Javornice brook near the village of Čistá, an integral part of the local railway Rakovník–Mladotice, has three spans of 12.5+57.0+12.5 m (Fig.34). In the outermost spans there are stone arch structures. In the mid-span there is a steel beam truss bridge with a lower parabolic chord. The 12-span truss is of the Howe truss-type. The axial distance of the main girders is 3.6 m. The upper chords are of a  $\Pi$ - section, the lower chords are of two inverted T-sections. The verticals and diagonals are made of segmental members with truss connectors. The bridge has two levels of horizontal bracing at the upper and lower chords. There is a transverse truss stiffening at each vertical. The crossbeams are riveted plate girders, the stringers are welded plate girders and are mounted on top of the crossbeams. The stringers have vertical bracing placed in the mid-span. The superstructure is supported by steel fixed and roller bearings. The substructure is from stone masonry. The bridge was built in 1898 and underwent reconstruction in 2010.

**Fig. 34.** The railway bridge near the village of Čistá; in the mid-span there is a steel beam truss bridge with a lower parabolic chord, span 57.0 m, from 1898 [20]

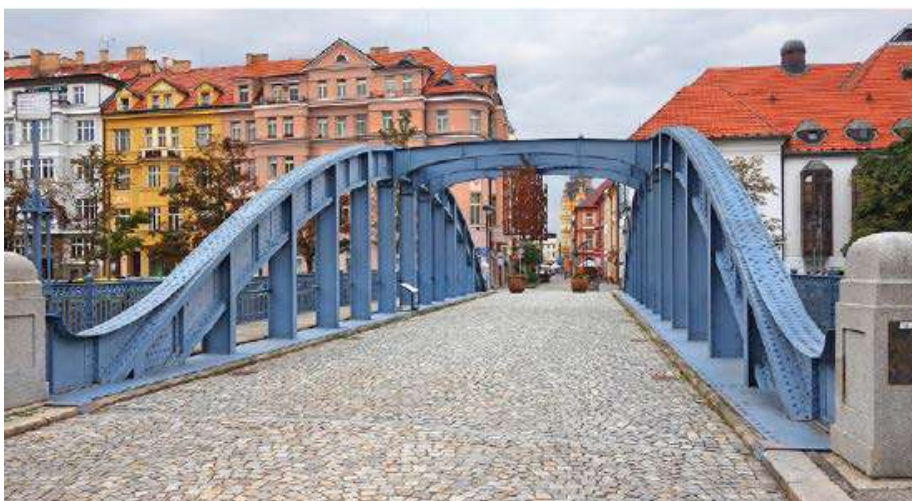
A road bridge over the River Malše with one span of approximately 40 m (Fig.35). The main load-bearing structure is a steel-tied arch. Currently it serves as a footbridge. There is a paved roadway between the arch-beams. Outside the tied arch, there are cantilevered sidewalks with a bridge deck made of timber. The main beam, upper arch chord, and vertical ties are riveted I-sections. There are three vertical frame portals in the mid-spans. The bridge deck consists of riveted I-section crossbeams, rolled I-section stringers and a bridge deck slab supported by trapezoidal plates. The bridge is supported by steel bearings. The bridge acquired its name during the Middle Ages, when a bridge stood in front of the Rožnov Gate, which was used by merchants when entering the town. The current bridge dates from 1915 and was built by the Prášil Brothers company of Prague-Libeň. The bridge was repaired in 2001.

**Fig. 35.** A road bridge over the River Malše with one span of approximately 40 m., from 1915[20]

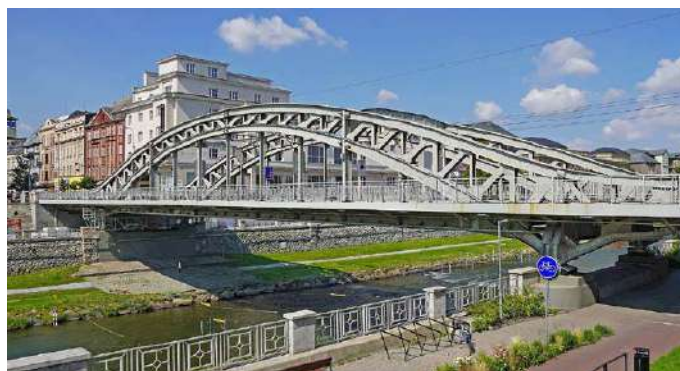
The Miloš Sýkora Bridge over the River Ostravice in Ostrava is a three-span bridge of the Gerber beam-type, featuring a load-bearing middle span and two suspended approach spans with span lengths of 16+60+16 m (Fig.36). The main span consists of a semi-through truss arch and lateral bracing at the level of the top chords. The approach spans are quadrangular trusses of a constant height with verticals. The bridge deck is formed by crossbeams, stringers, and a slab with a steel plate of lost formwork. The structure is riveted, with bolted

and embedded hinges. On the site of the current bridge, there used to be a timber structure, which was built in the 1830s. Due to its poor condition, it was replaced after eleven years by a chain bridge, manufactured by the Klein Brothers' Ironworks in Kladno. Even this bridge did not last very long. After 30 years, it collapsed on the 15th of September 1886, when a squadron of Hulan cavalry troops attempted to cross the bridge. Less than a year later, in 1887, a new bridge was in place, but its condition rapidly deteriorated too. It was replaced by the present bridge in 1914. The bridge was named after Miloš Sýkora, the legendary 24-year-old resistance fighter, who died while preventing the Nazis from blowing up the structure, thus enabling the Red Army's rapid advance during the battle for Ostrava.

**Fig. 36.** A road bridge over the River Ostravice with a three-span bridge of the Gerber beam-type with span lengths of 16+60+16 m, from 1914[20]

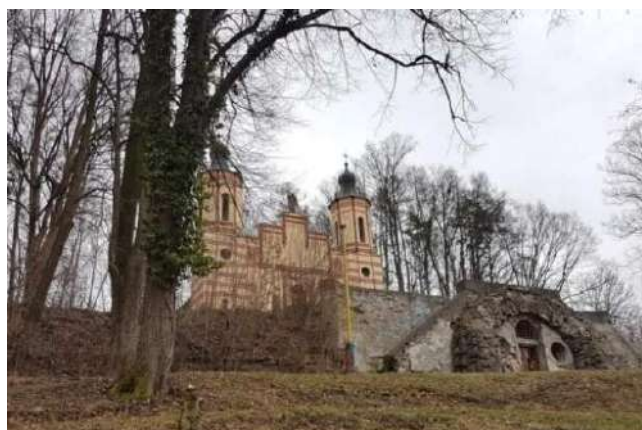
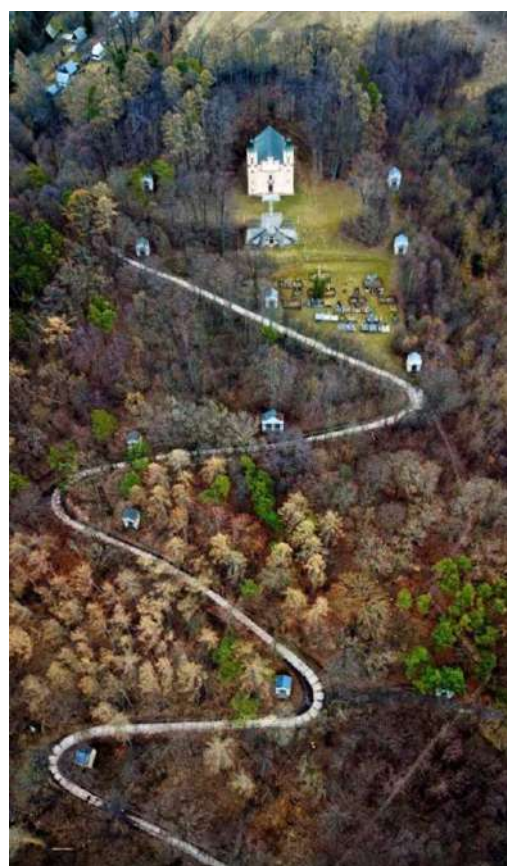
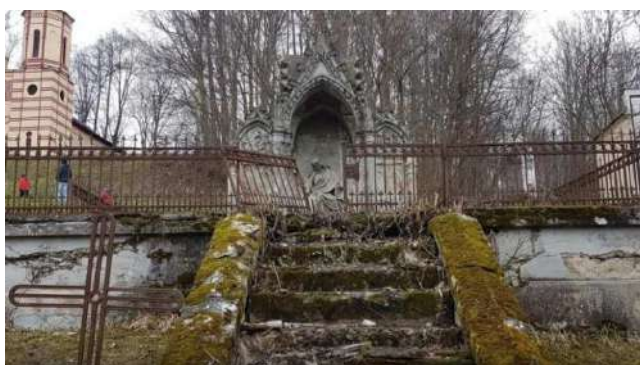
**Fig. 11.** a) Calvary at Bardejov. Beginning of building 1863, finished in 1868, sainted in 1869 (courtesy of bardejov.sk, J. Ličková, Korzár Prešov, K. Gécziová); b) Dron photography (courtesy of Filip Liskay).

Calvary (Figure 11) is located not far from Bardejov centre. It consists from the church Exaltation of Holy Cross and 14 chapels. Twice a year the calvary is the site of large regional pilgrimages. Calvary lacks an adequate road, new benches and lighting. The chapels also need renovation. It needs urgently renovation. However, after years there is a plan to improve this place.

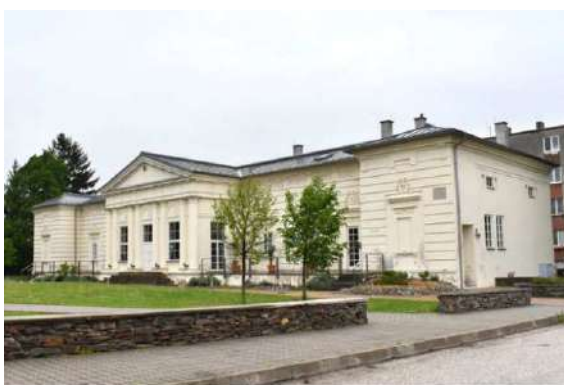
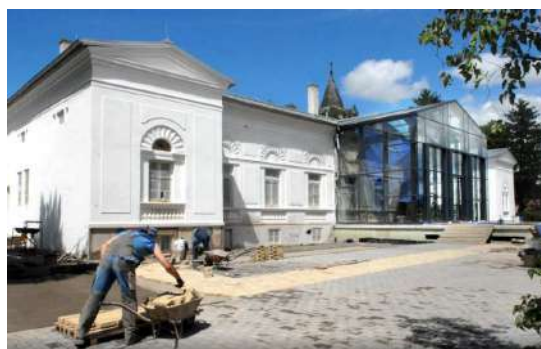
**Fig. 13.** Classicist mansion in Krásna near Košice (courtesy Korzár / Judita Čermáková).

Thanks to the European Capital of Culture 2013 project, about 20 objects in Košice have been improved, reconstructed and made operational. One of the most beautiful Slovak classicist mansions in Krásna (Figure 13) was reconstructed from ruins for 1,2 million euro.

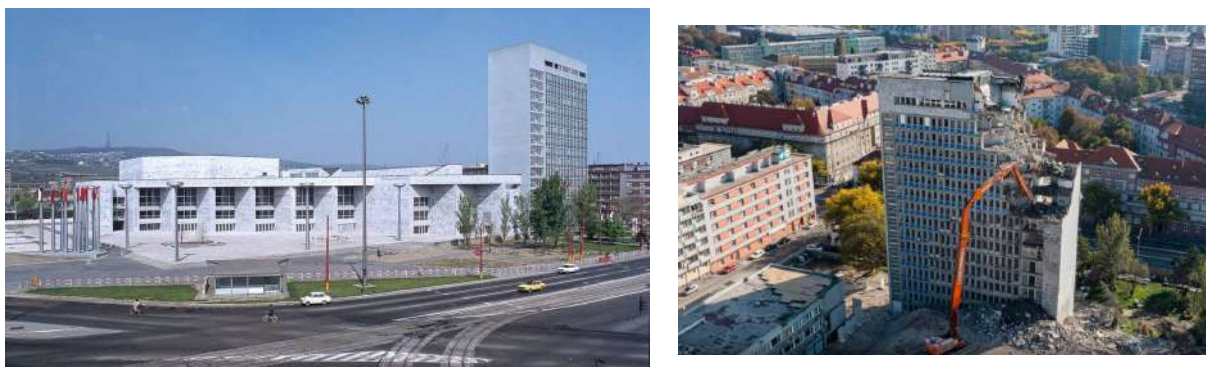
**Fig. 14.** Istropolis, the House of Trade Unions on the Trnava Mýto in Bratislava

The famous Slovak architects Ferdinand Konček (1929), Il'ja Skoček (1930-2022), Ľubomír Titl (1929-2018) won in 1956 competition and designed the building of the House of Trade Unions which was opened in 1981. The building of the House of Trade Unions on the Trnava Mýto in Bratislava, also known as Istropolis, was built in the 1980s. It served as a conference palace for the leaders of the communist regime. After 1989, it was the property of the trade unions. The municipality tried to buy it, but no agreement was reached. The union sold Istropolis to a private investor in 2017. After longer resistance and hesitation the municipality decided in January 2022 that Istropolis may be removed. Developer plans to demolish the building and build the New Istropolis project there. Titl and Skoček died without knowing that their work will be destroyed.

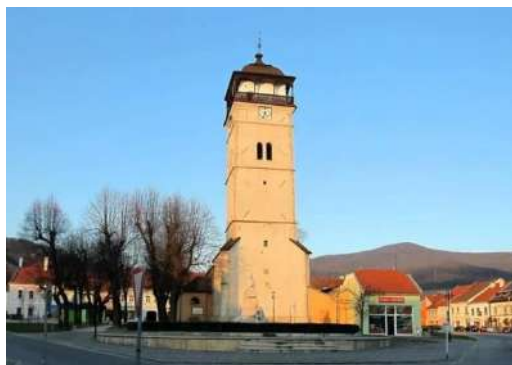
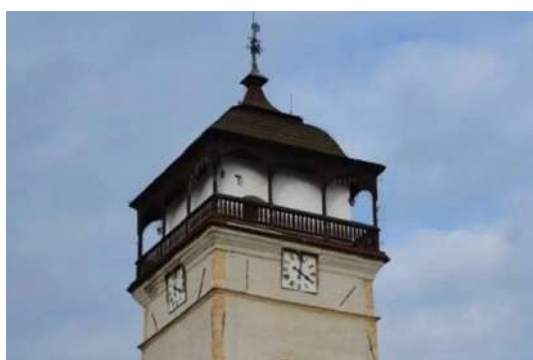
**Fig. 3.** The late-Renaissance watchtower is a dominant feature of the historical center of Rožňava, old mining town. It was built in the years 1643-1654, that is, in the period when the country was threatened by the Turks and it performed an important defense function. The Turkish cannon ball can still be seen in its southern facade. (Courtesy of TASR).

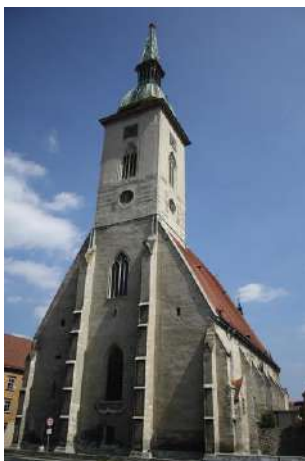
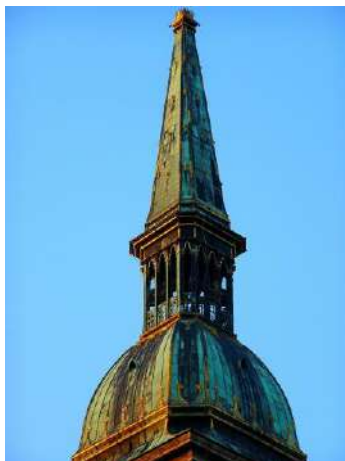
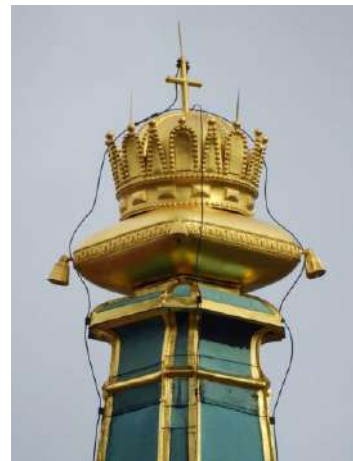
**Fig. 5.** The second highest church in Slovakia: the St Martin's Cathedral in Bratislava. Compare it with Fig.2. The tower is 85 m (279 ft) high and at one time was part of the medieval city fortifications. The cathedral is constructed in the traditional crucifix shape. It is the largest and one of the oldest churches in Bratislava, known especially for being the coronation church of the Kingdom of Hungary between 1563 and 1830. The tower is capped by a replica of the Hungarian Crown resting on a gilded pillow.  
(Courtesy of Wikipedia).
