**ДОКЛАДИ  
МЕЖДУНАРОДНА НАУЧНА  
КОНФЕРЕНЦИЯ  
ПО ОПАЗВАНЕ  
НА  
НЕДВИЖИМОТО КУЛТУРНО  
НАСЛЕДСТВО  
БАНИ' 2022**

**PROCEEDINGS  
INTERNATIONAL SCIENTIFIC  
CONFERENCE  
PRESERVATION  
OF CULTURAL HERITAGE  
BASA' 2022**

| <b>стр. 282-306</b> | SEISMIC DAMAGE OF BUILDING STRUCTURES AND THEIR REHABILITATION<br><b>Radomir Folić, Miloš Čokić, Boris Folić, Angelos Liolios</b> |

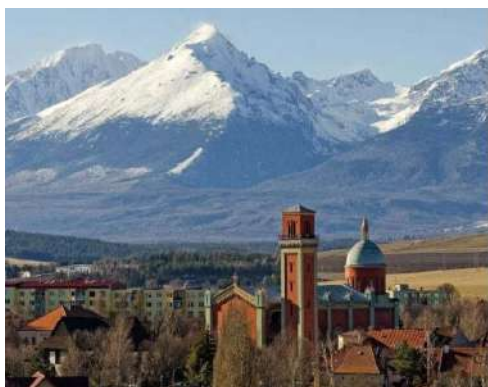
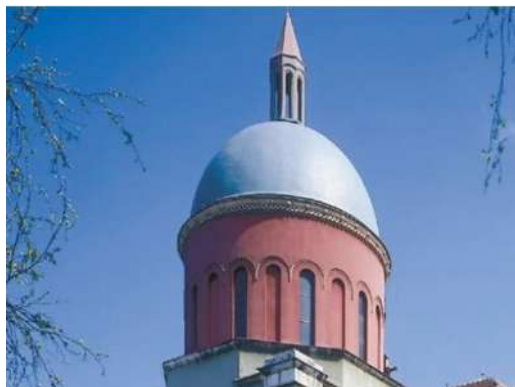
**Fig. 7.** In the second half of the 19th century, the Evangelicals from Kežmarok, former king town, decided to build a new church. That is why the delegation in 1870 chose the Danish civil engineer Teofil von Hansen, at that time the chief landscape architect in Vienna, who presented his own projects and those - as tradition says - were originally intended for the Orient. Construction lasted 22 years with an 11-year break. The height of the tower is 42 meters and the height of the dome is 33 meters. (Courtesy of TASR).

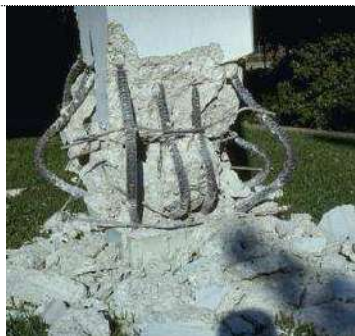
**Fig. 1.** Poor detail of transversal reinforcement

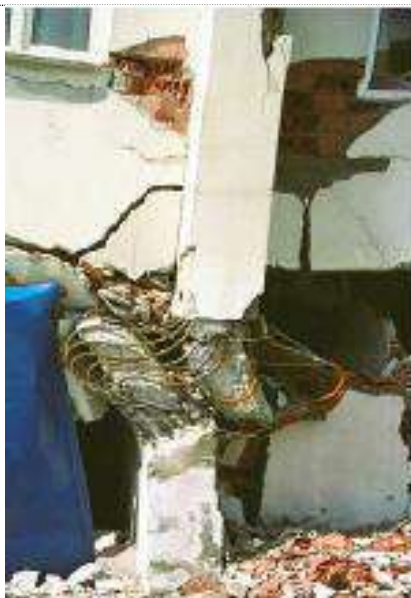
**Fig. 3.** Collapse with column shear and axial failure. Koceali Eq. 1999.

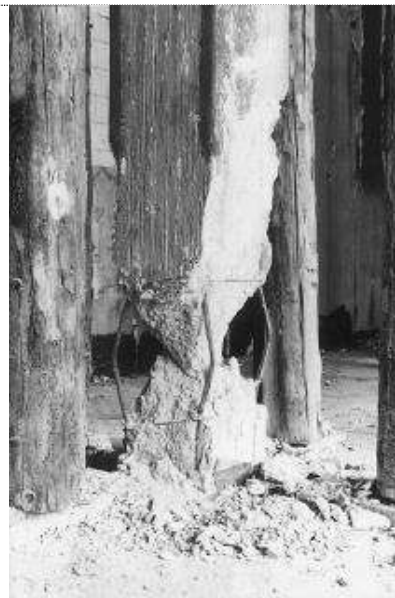
**Fig. 4.** Column failure due to excessive axial load and insufficient stirrups

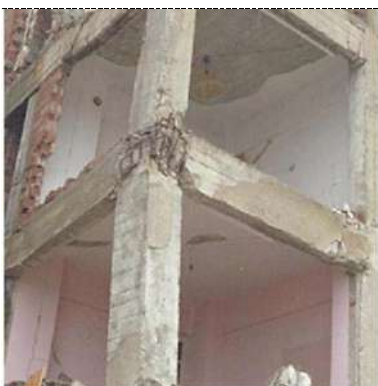
**Fig. 5.** Beam-column joint damage, Turkey, Koceli, 1999, after [17]

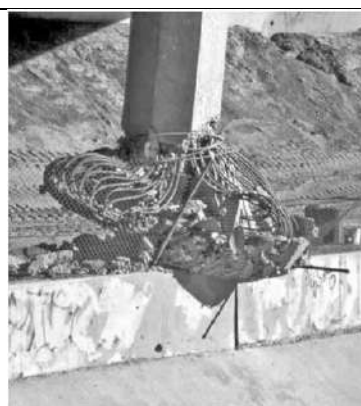
**Fig. 6.** Bursting failure in a column, Northridge, California, 1994, after [5]

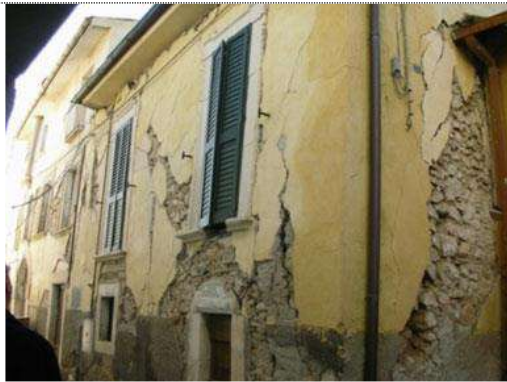
**Fig. 11.** Severe damages to shear walls and spandrels 2009 Eq. L'Aquila, Italy, [22]

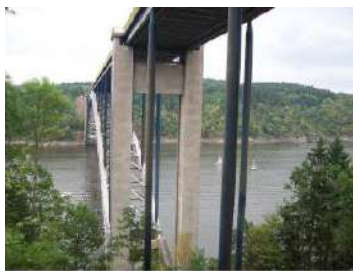
**Фиг.8.** Изглед на конструкцията на моста **Фиг.9.** Дъга под стойката **Фиг.10.** Укрепване между дъгите

Дъгообразните греди са с кутиеобразно сечение с височина 5000 mm, с осово разстояние на стените 1000 mm (фиг. 9). Вертикалните стебла на гредата са разделени по средата на височината им по производствени причини, като непрекъснатата надлъжна връзка е реализирана с нитовани съединения. Промяната на напречното сечение на дъгата по дължината и, се извършва с помощта на променящ се брой занитени сравнително тънки фланцевидни плочи. Формата на напречното сечение на кутиеобразното сечение се осигурява от напречни диафрагми. Под стойките, поддържащи гредата на мостовата пътна конструкция, има пълностенни диафрагми с люкове в напречното сечение, докато в междинните напречни сечения са разположени през 4000 mm прътови диафрагми. Стените на кутиите на дъгите са укрепени с едностранни надлъжни ъглови профили. Две от тях са заварени от външната страна на кутията, като по този начин допринасят за по-добър естетически изглед на моста. Във вътрешността на кутиеобразното напречно сечение на дъгата е разположена надлъжна прътова връзка в половината от височината ѝ, която осигурява формата на половините на дъгата по време на транспорта и монтажа и. Сводовите греди са изработени от стомана S355. Надлъжните прътови стабилитетни връзки в горния и долен пояс на дъгите имат формата на К-система. Отделните усилващи пръти са изработени от стомана S355 и имат кутиеобразно напречно сечение за коравина и лесна поддръжка. Те са изпълнени от заварени напречни сечения. Връзките на тези пръти към дъгите са изпълнени с нитовани съединения. Подобно изпълнение притежават и диагоналите на междинните радиални връзки, чиито детайли на свързване към дъгите са също нитовани (фиг. 10). Напречните връзки в петите на дъгите са изпълнени от пълностенно, с височина 5000 mm, кутиеобразно напречно сечение.

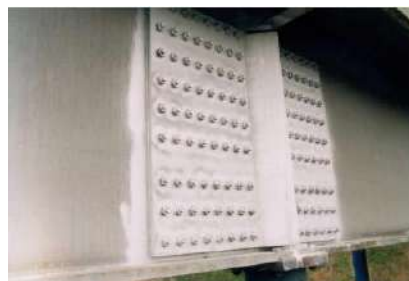
**Фиг. 15.** Схема на стеблото в главната греда на мостовата конструкция с очерчания на пукнатината

Мостът Ждяков е в непрекъсната експлоатация до 1998 г., и дотогава не е извършван основен ремонт на носещата конструкция. Извършвана е само редовна поддръжка. Визуално мостът изглежда все още доста добре в края на 90-те години. Ето защо е поднесена голяма изненада, когато като част от редовната поддръжка в края на лятото на 1998 г. открива, че на три места в стеблото на мостовата греда се виждат дълги вертикални пукнатини, минаващи почти по цялата височина на стеблото на гредата, фиг.14 и фиг.15, [15, 16, 19].

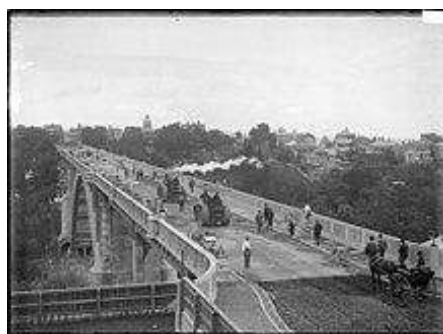
**Fig.5.** Gmündertorbelbrücke, 1907/1908; **Fig.6.** Grafton Bridge, Auckland, New Zealand, 1908/1910;

**2.4. Мост Grafton, Auckland(Оукланд), Нова Зеландия, 1908/1910 (Фиг.6).**

Мостът свързва двете новозеландски държавни магистрали. Това е стоманобетонен мост, пуснат в експлоатация през 1910 год. с дължина на свода 97,60m, претавляващ в онази епоха най големият мост от този вид в света.

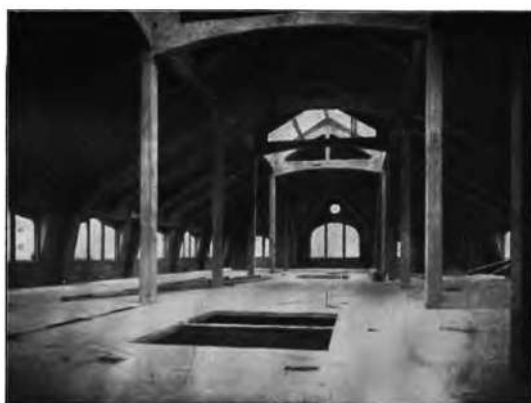
FIG. 233.—Loft of the forge shop of the Daimler motor factory.

Фиг.13.Таванско помещение на ковашкия цех

На фиг. 13 е показано таванско помещение на ковашкия цех на фабриката за автомобили на Daimler. На Фиг.14 е дадено стълбище ст стоманобетон от XIX век.

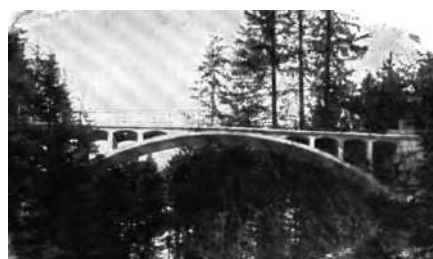
Фиг. 21. Мост на магистралата в Гунзесрид (Алгау) - Германия. Междуосие 32 м

Осите на ребрата на тези мостове са приети като параболи, за да могат да се приложат с предимство известните формули за непосредствено изчисление на линията на влияние за моментите в определено напречно сечение на параболичната дъга. Тъй като обикновено осите на дъгите се приемат така, че да съвпадат с линията на натиска за собственото натоварване, в горните случаи се приема, че формата на параболата е допустимо избрана, тъй като собственият товар е малък и почти равномерно разпределен по целия диапазон. Трябва да се отбележи особено, че тук връзката с брега е осъществена посредством бетонни стени, които затварят кухо пространство, покрито

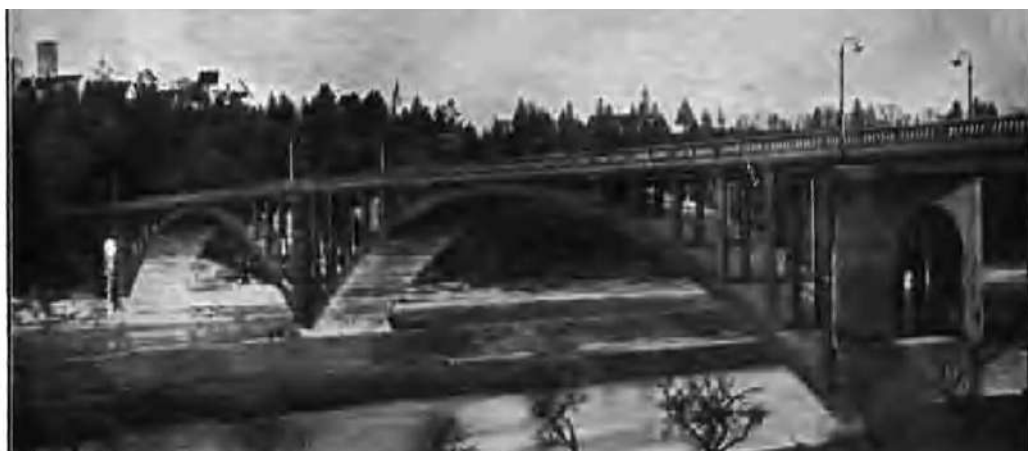
Фиг. 22. Магистрален мост над река Изар край Грюнвалд – Германия

На фигура 22 е показан магистрален мост над река Изар край Грюнвалд – Германия.

Мостът на магистралата е с дължина около 220 м., с две арки с размах от 70 м., над коритото на река Изар и захранващия канал за електрическата централа. Двете главни полета са проектирани като арки с три ставни устройства. Пътното платно е издигнато над проектната кота с помощта на колони, подпрени върху дъгите на моста.
