доклади  
МЕЖДУНАРОДНА НАУЧНА  
КОНФЕРЕНЦИЯ  
ПО ОПАЗВАНЕ  
НА  
НЕДВИЖИМОТО КУЛТУРНО  
НАСЛЕДСТВО

proceedings  
INTERNATIONAL SCIENTIFIC  
CONFERENCE  
“PRESERVATION OF CULTURAL HERITAGE”

BASA' 2019  
21-23 november 2019

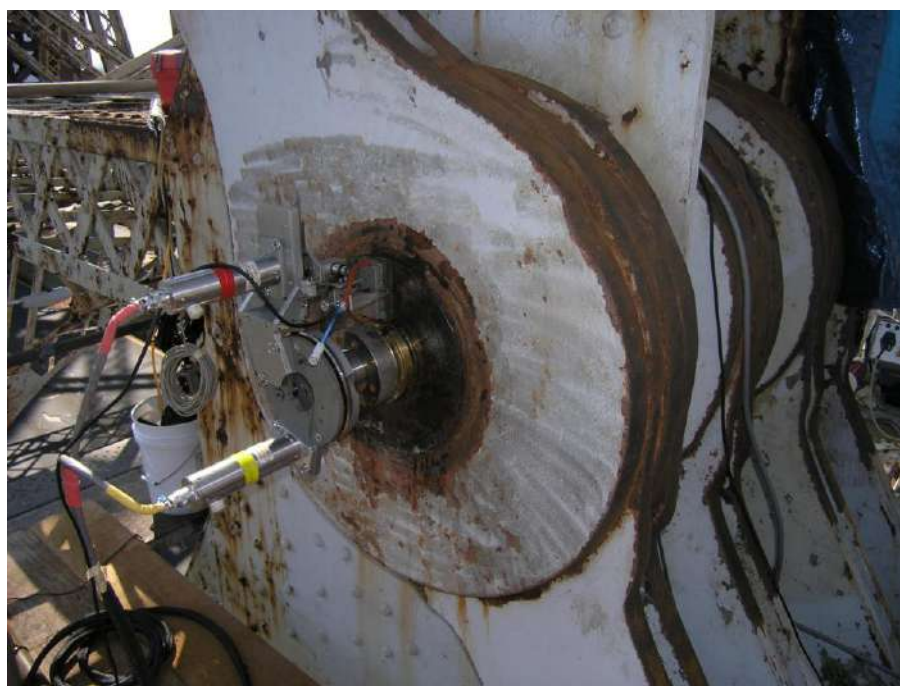
In the pins, relevant indications were generally limited to mismatch in the 50 mm diameter bore hole down the longitudinal axis of the pin. One pin was found to have a significantly reduced diameter. Figure 5 shows a typical testing of a pin in progress.

Fig. 5. Phased-array ultrasonic testing of a pin

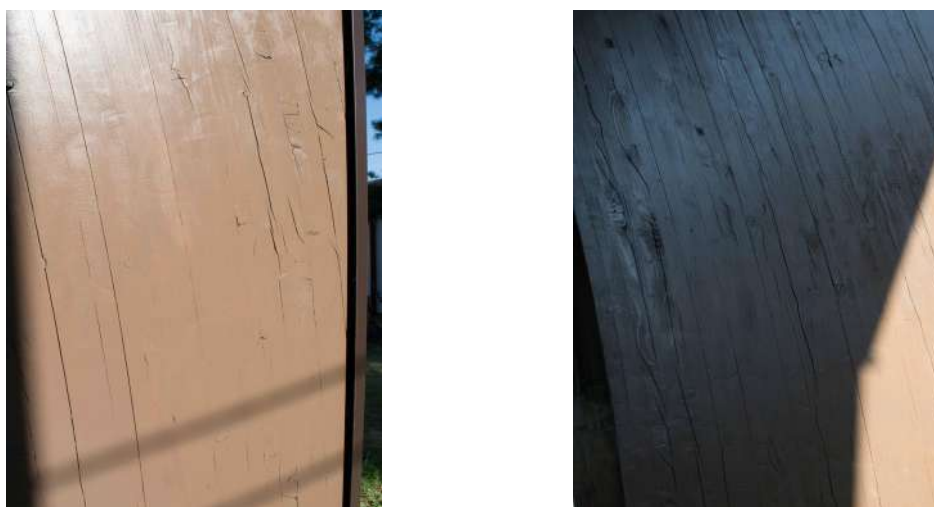
**Fig. 4.** Degradation of the main girders

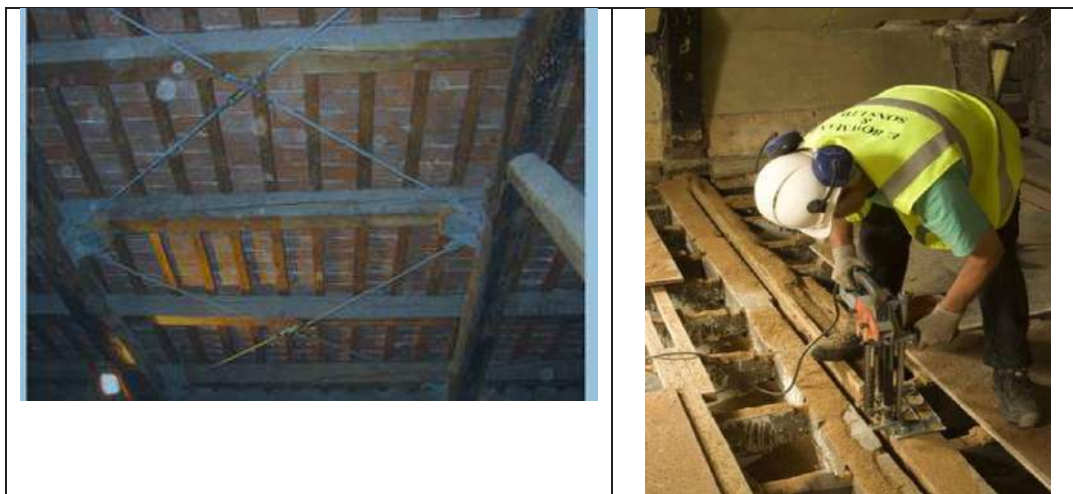
**Fig.6.** Visible and hidden use of steel elements for reinforcement of the floor beams

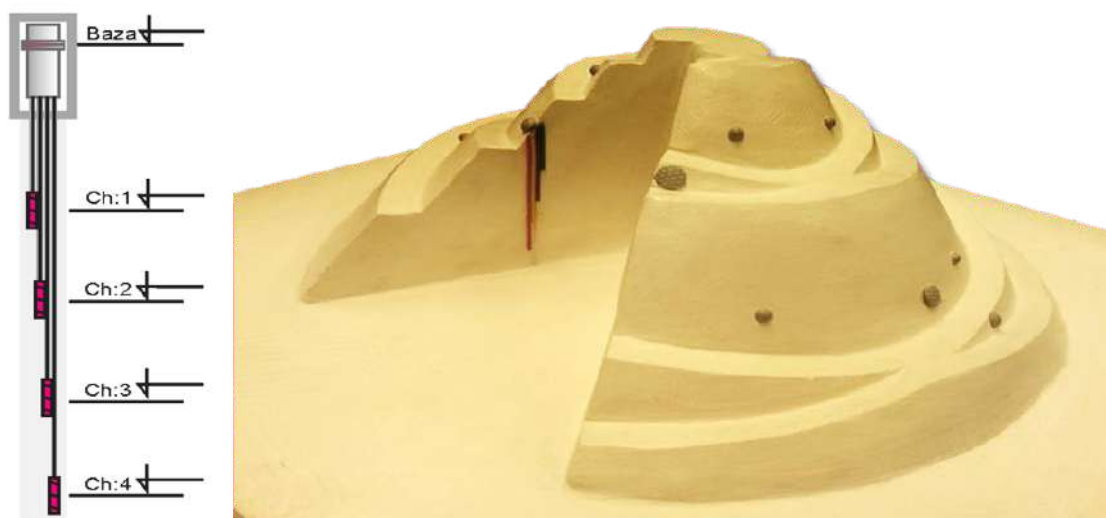
**Fig. 5.** Details of vertical displacement measurements.

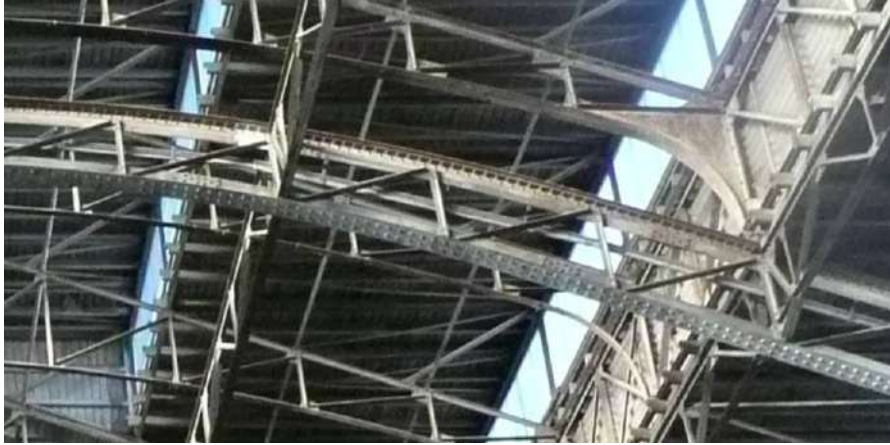
**Fig. 10.** Connection of top truss to main roof truss

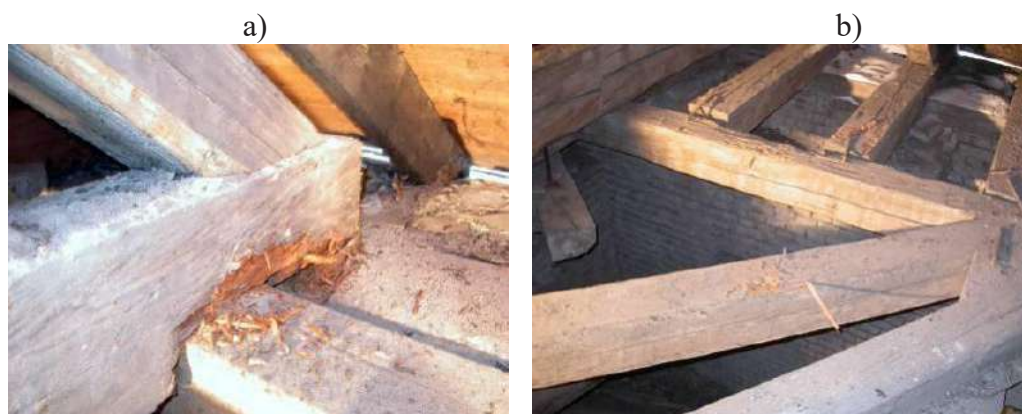
**Fig. 14.** Details of rot (a) and wormholes (b) in timber elements

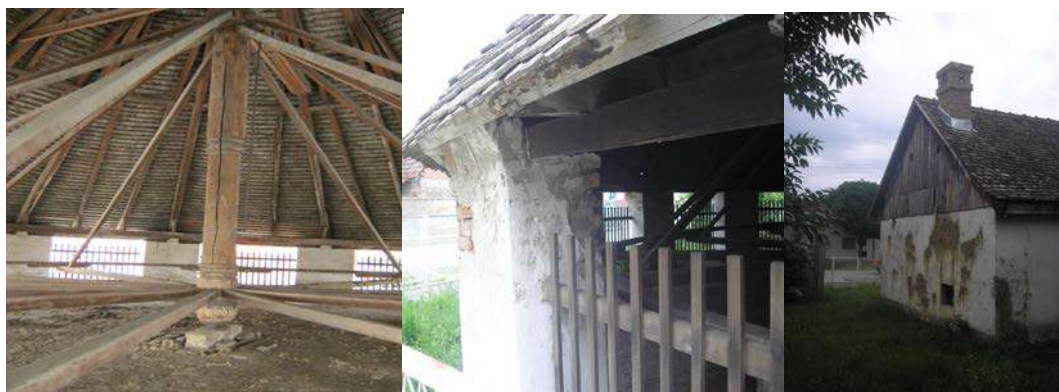
**Fig. 2.** Photos of damage pillar „popa, short walls of baked bricks and walls of adobe bricks

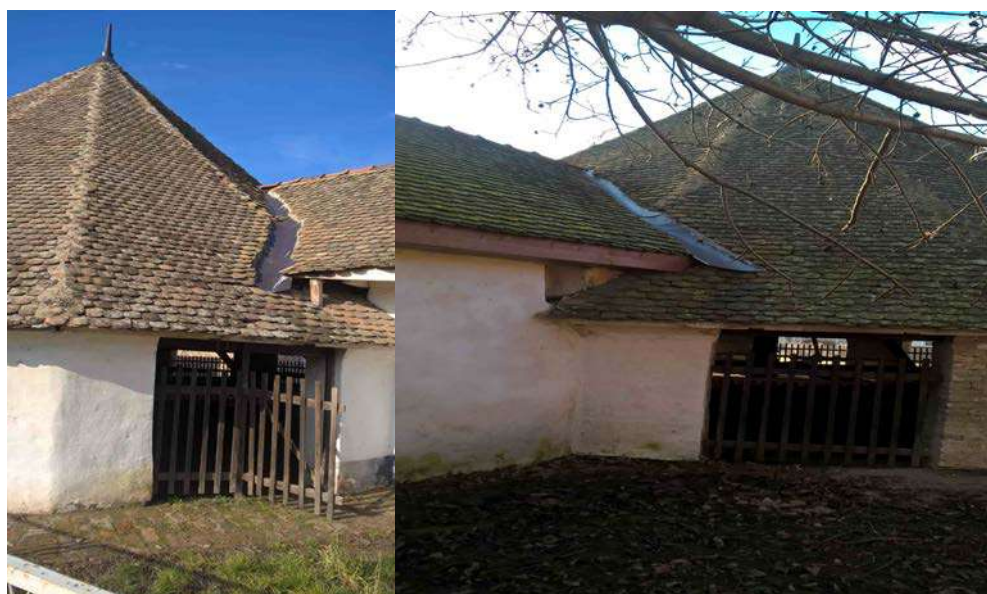
**Fig. 7.** Rehabilitation of the roof

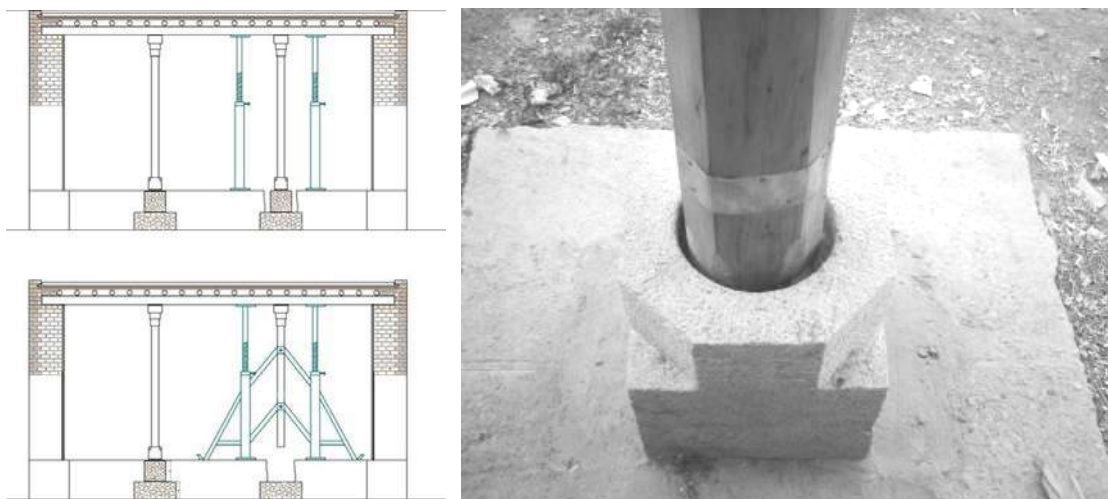
**Fig. 24a:** Collapsing the decayed foundation and restoration of the foundation
