**ДОКЛАДИ  
МЕЖДУНАРОДНА НАУЧНА  
КОНФЕРЕНЦИЯ  
ПО ОПАЗВАНЕ  
НА  
НЕДВИЖИМОТО КУЛТУРНО  
НАСЛЕДСТВО  
БАНИ' 2020**

**PROCEEDINGS  
INTERNATIONAL SCIENTIFIC  
CONFERENCE  
PRESERVATION  
OF CULTURAL HERITAGE  
BASA' 2020**

**21-23 november 2020**

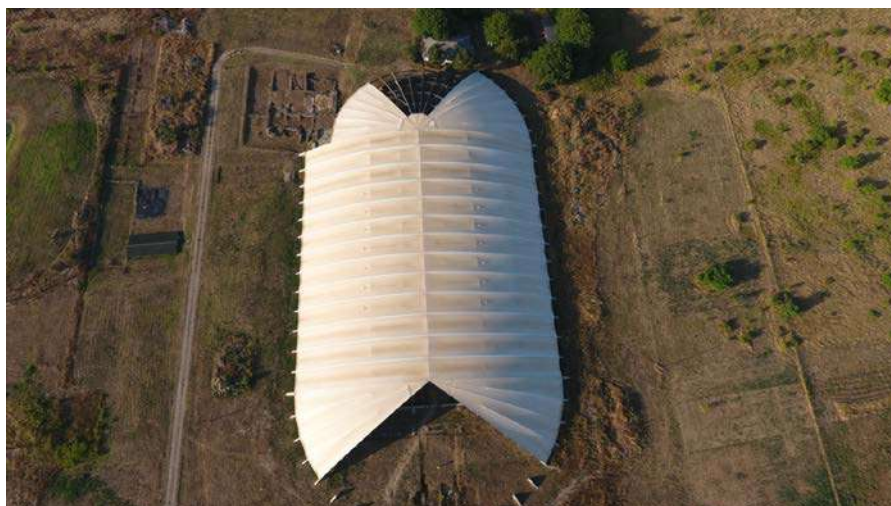
**Fig. 2** The first phase of construction of the protective structure (2015)

The protective membrane construction was partially erected on the site in 2014 (Fig. 2), and completed by about 85% in 2019 (Figure 3). This is not the first protective building erected on the site, namely in 1936 a masonry building of the Mediana Museum was constructed above the triclinium with the intention of protecting the mosaic found in that building. The museum building was incorporated into a new project of a protective structure that was erected above the entire villa with a peristyle, with the intention that the mosaics discovered in the villa could be revealed and shown to the public at least most of the year. However, soon after the protective structure was erected in 2014, it became apparent that the emerging climatic conditions were creating more problems than before, so the mosaics were still covered with geotextiles and sand to prevent their further devastation.

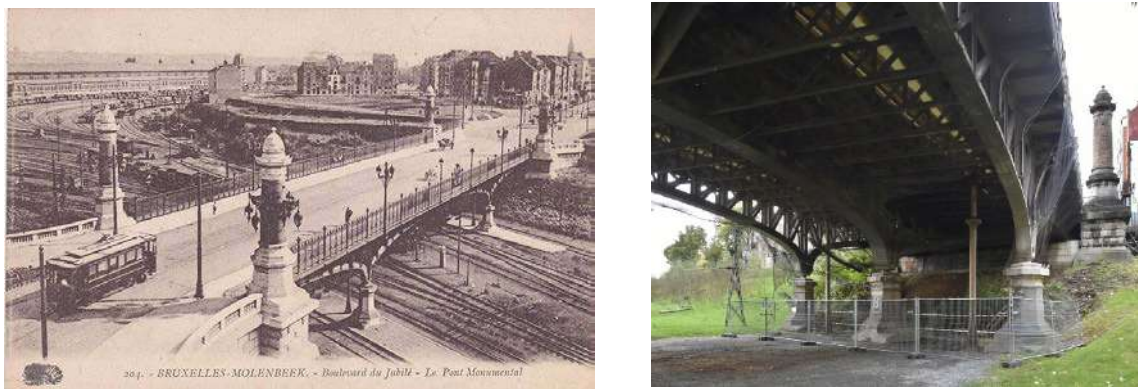
**Fig. 2.** Boulevard du Jubilé bridge (left : original, right today)

The connection to the railway network required passing below the 'Boulevard du Jubilé' and Bruneel designed a remarkable steel bridge in the typical Brussels' version of 'art nouveau'. This bridge is still in use and can be seen in its original state in Fig. 2 left and present state Fig. 2 right.

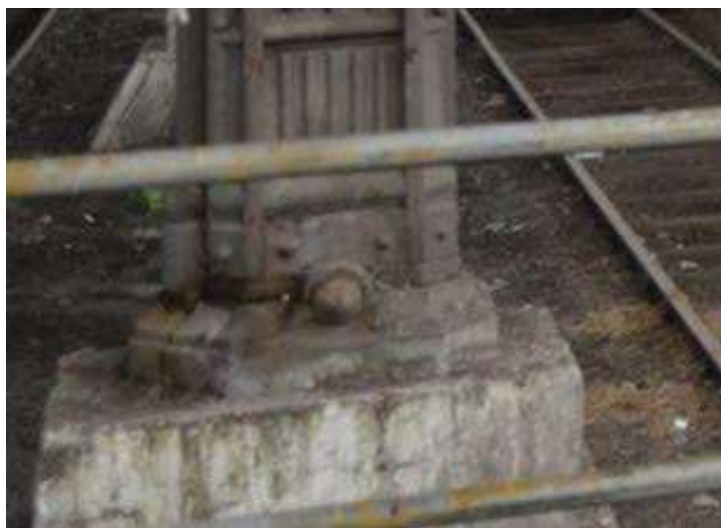
**Fig. 6.** Hinge at the base of heavy columns (© GOB-DML)

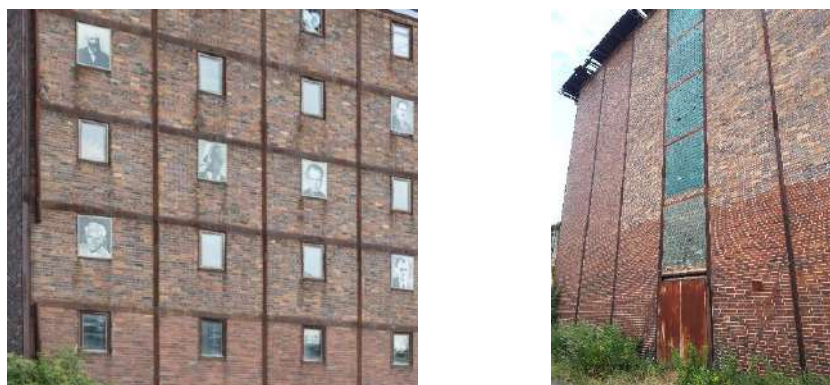
**Fig. 7.** Outer steel skeleton with corrosion damage

The destroyed roof and the windows have to be fixed urgently to keep moisture and other weather conditions outside. After fixing of the outer cover, the whole steel skeleton structure is to be checked. A damage from corrosion is largely visibly (Fig. 7) and it will continue to progress unless counter action is provided. Most columns and bars will need a surface blasting with new coating.

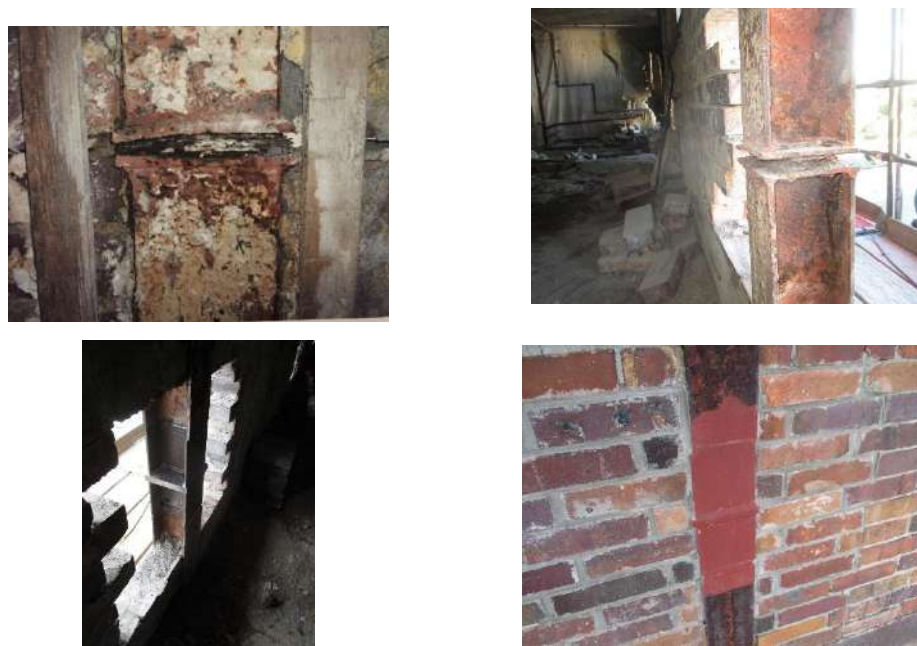
**Fig. 8.** Column in the building with corrosion damage and its rehabilitation

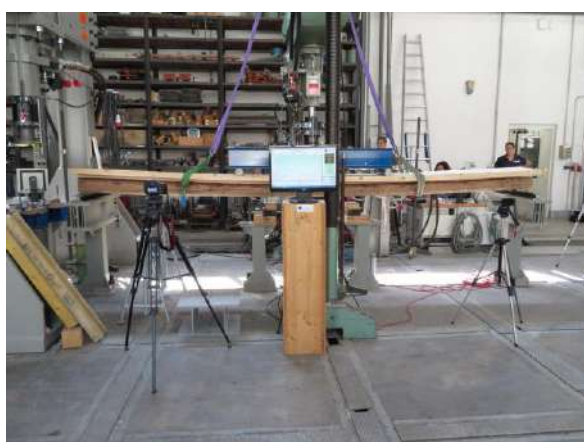
**Fig. 12** 4-point bending test on the test beam  
source: Jäger

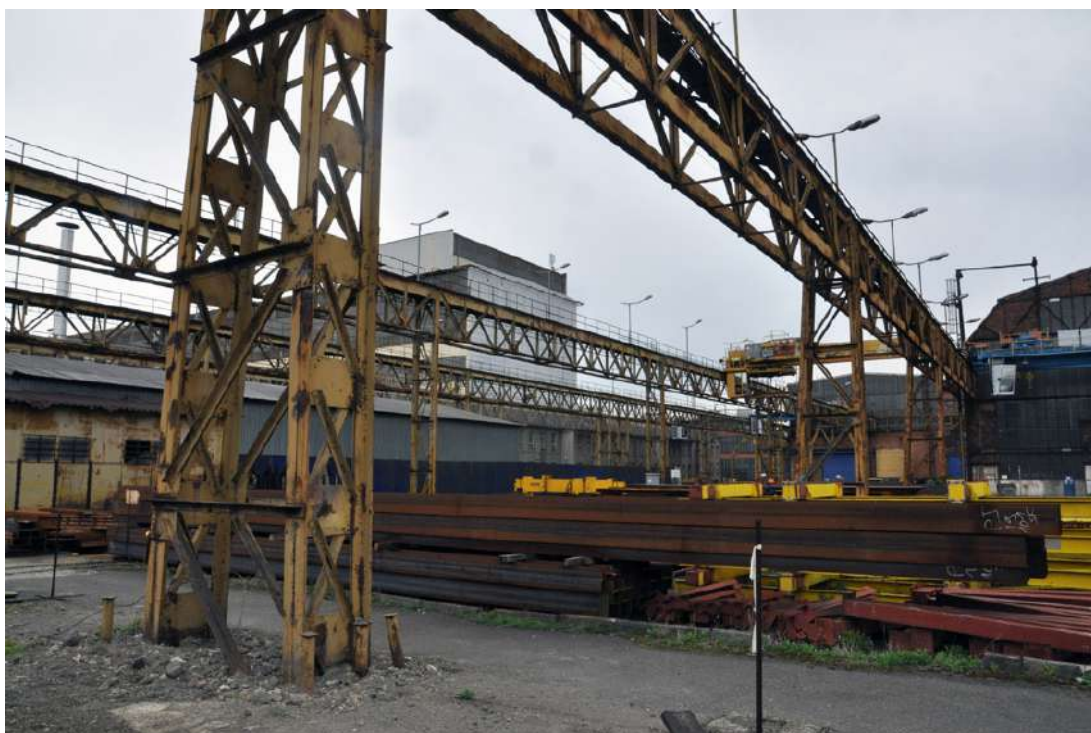
**Fig. 1.** Steel truss structure supporting an overhead crane

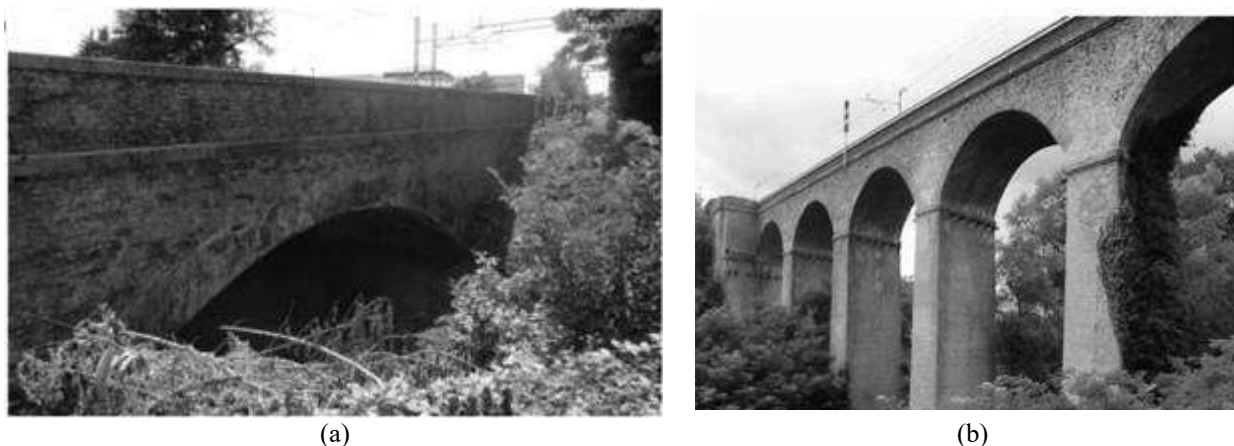
**Fig. 3.** Analysed bridges (a) single span (b) multi-span [19].

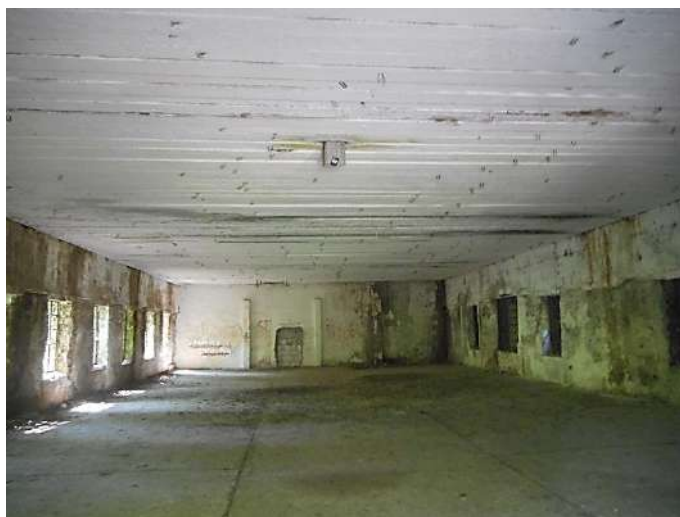
**Fig. 10** View of the ceiling with pre-tensioned beams and concrete topping (own photo)

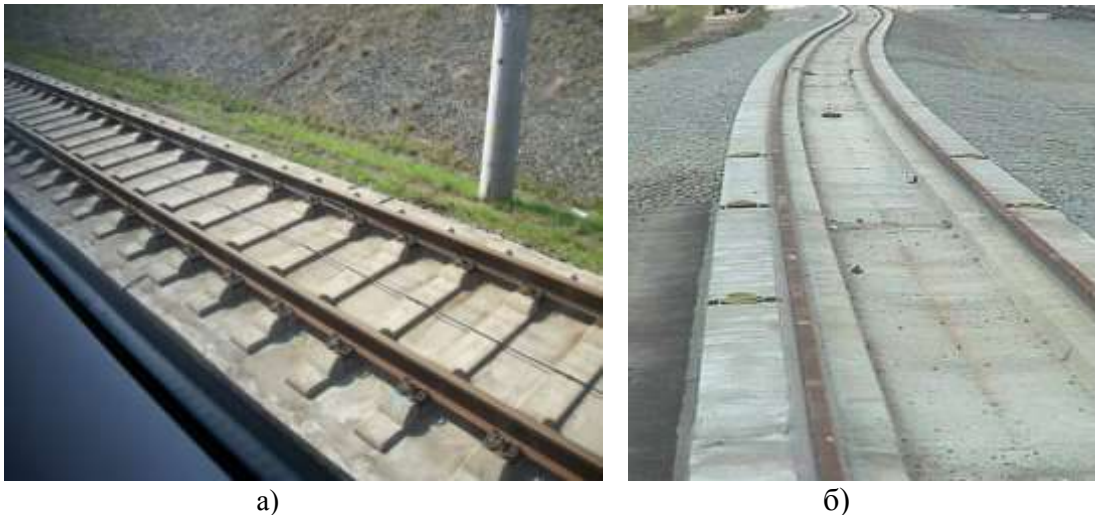
**Fig.3.** Ballastless track: a) with discrete support б) with continuous support
